Hot Dip Galvanized Case Study No. 4

Hot Dip Galvanized Reinforcement in Concrete

This case study is the result of a detailed investigation of a pedestrian bridge situated along the foreshore of Algoa bay.

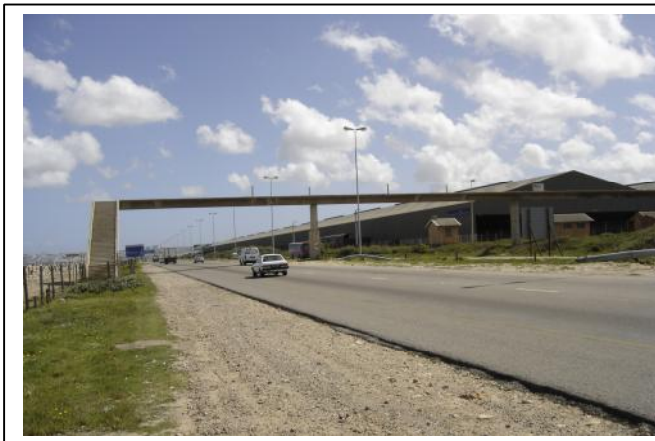
The site of the 40-year-old pedestrian bridge (No B776), due to be demolished. (April 2005). It was established that hot dip galvanized reinforcement was used in the approach stairway, which was on the sea facing side, indicated on the left of the photograph, with the sea some 50 meters further left.

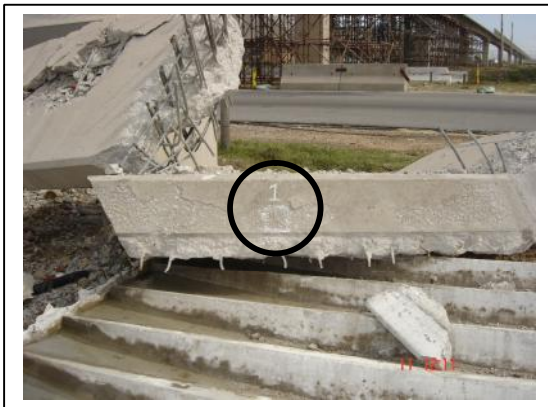
2 Core Samples

Carbonation was found to be more severe on the landside of the structure, with penetration depths of 18 to 22 mm.

Taken on the side facing inland. Carbonation penetration 18 to 22 mm, chloride level at 45 to 60 mm 0.15% to 0.65% as mass of cement.

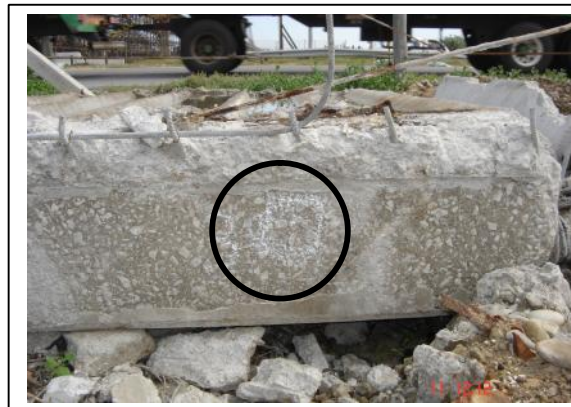
2 Core Samples

Chloride concentrations (% as mass of cement) at a depth of 45 to 60 mm ranged between 0.15 & 0.65 on side facing inland, and 0.27 & 1.26 on the sea facing side. At a depth of 30 to 45 mm the chloride concentrations ranged between 0.19 and 2.6. Chloride levels at a depth of 15 to 30 mm rise to between 0.49 to 8.8 as a % of cement mass. Accepting that the typical limit is 0.1% chloride for uncoated reinforcement, it should be totally unacceptable to use plain reinforcing without additional corrosion protection in this environment.

Taken on the sea facing side. Carbonation penetration 5 to 23 mm, chloride levels at 45 to 60 mm 0.27% to 1.26% as mass of cement.

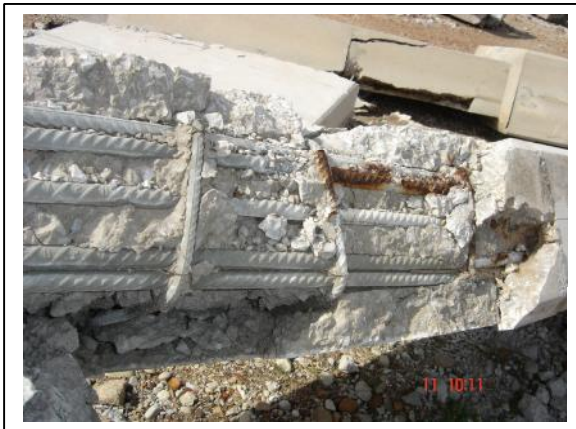
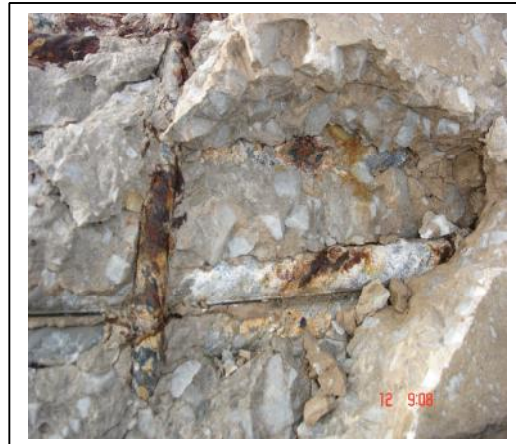
Notwithstanding the findings at the 45 to 60 mm depth of cover, numerous reinforcing bars were found at depths of 15 to 45mm. Even at the reduced concrete cover depths and increased chloride levels, the hot dip galvanized coating was continuing to protect the reinforcing bars. In certain isolated cases where the corrosive conditions had penetrated to the steel, due to very limited cover, the zinc had been sacrificed and some attack was evident of the carbon steel.

Isolated red rust was found, usually associated with minimum concrete cover and/or mechanical damage to the concrete cover.

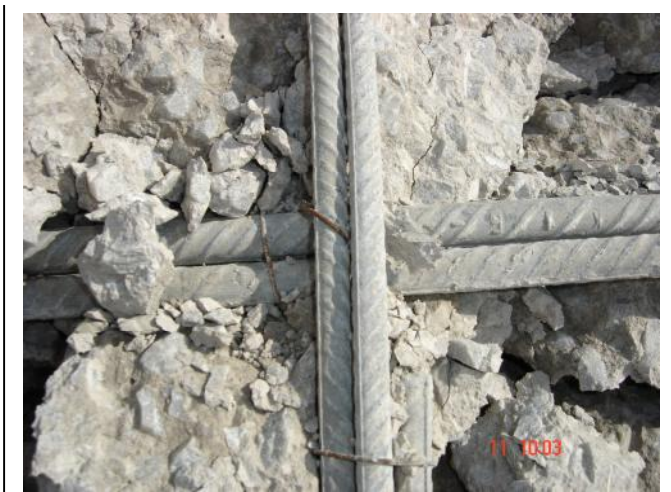
The condition of exposed hot dip galvanized reinforcement found during the demolition of the 40 year old bridge.

With isolated exceptions, the hot dip galvanized reinforcing shown, in this photograph, is typical of 98% of that inspected.

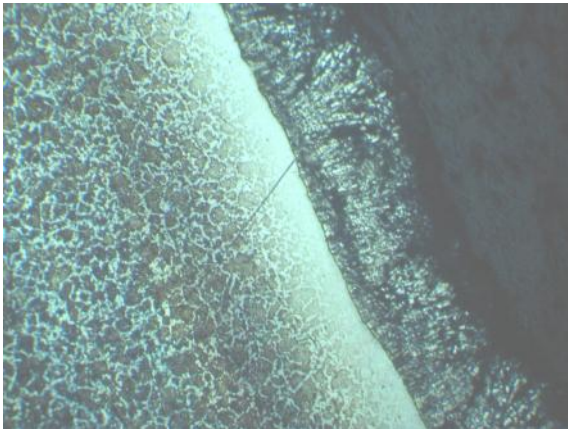
A transverse cross section through the bar revealed a 'normal' galvanized zinc skin with the constituent sub-layers clearly delineated (Figures 1 and 2). The galvanized skin thickness was 240-260 μ m.

Figure 1.
Galvanized layer (70 to 90 μ m)
on the reinforcement bar
(100X).

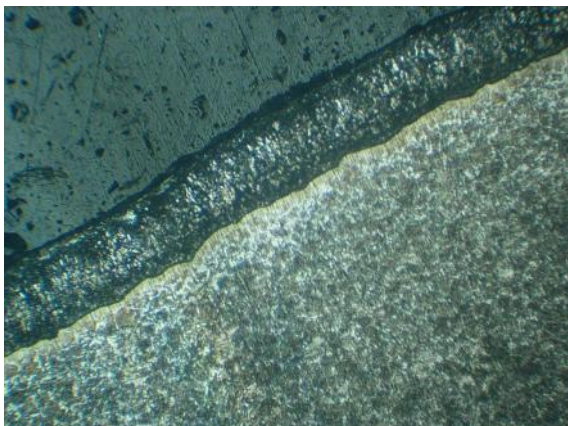
Figure 2.
Galvanized layer on the
reinforcement bar 45 to 50 mm
cover. (100X)
