Hot Dip Galvanized Case Study No. 4 (Revision)

Hot Dip Galvanized Reinforcement in Concrete

This case study is the result of a detailed investigation of a pedestrian bridge situated along the foreshore of Algoa bay.

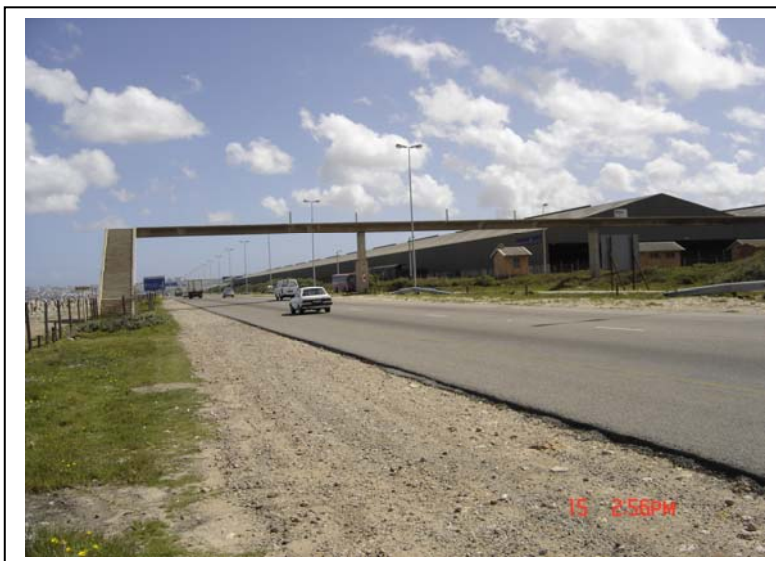
The site of the 40-year-old pedestrian bridge (No B776) that was demolished in April 2005. It was established that hot dip galvanized reinforcement was used in the approach stairway, which was on the sea facing side, indicated on the left of the photograph, with the sea some 50 meters further left. This stairway was part of a refurbishment of the seriously corroding structure in 1985.

From information received the hot dip galvanized reinforcing in the refurbished stairway (1985) had been in service for 20years

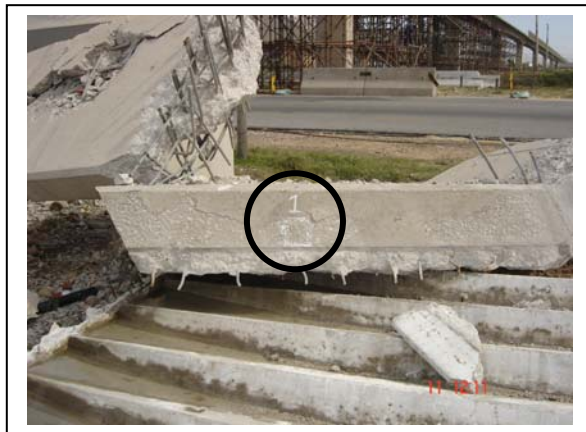
2 Core Samples

Carbonation was found to be more severe on the landside of the structure, with penetration depths of 18 to 22 mm.

Taken on the side facing inland. Carbonation penetration 18 to 22 mm, chloride level at 45 to 60 mm 0.15% to 0.65% as mass of cement.

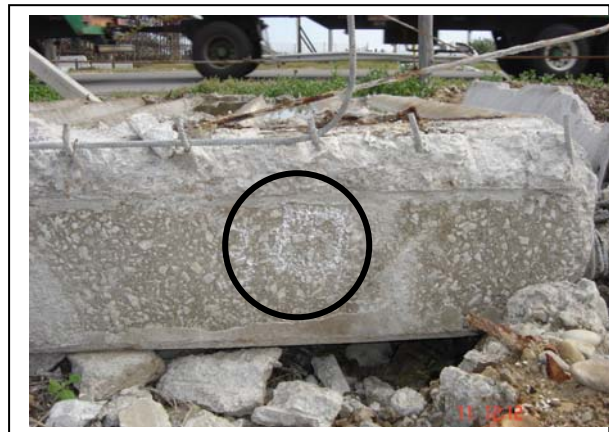
2 Core Samples

Chloride concentrations (% as mass of cement) at a depth of 45 to 60 mm ranged between 0.15 & 0.65 on side facing inland, and 0.27 & 1.26 on the sea facing side. At a depth of 30 to 45 mm the chloride concentrations ranged between 0.19 and 2.6. Chloride levels at a depth of 15 to 30 mm rise to between 0.49 to 8.8 as a % of cement mass. Accepting that the typical limit is 0.1% chloride for uncoated reinforcement, it should be totally unacceptable to use plain reinforcing without additional corrosion protection in this environment.

Taken on the sea facing side. Carbonation penetration 5 to 23 mm, chloride levels at 45 to 60 mm 0.27% to 1.26% as mass of cement.

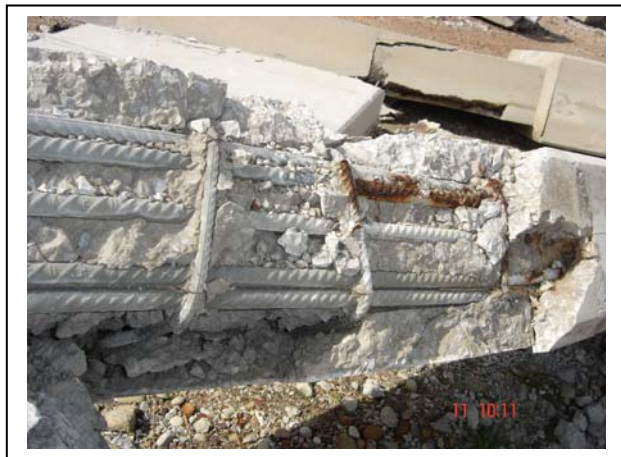
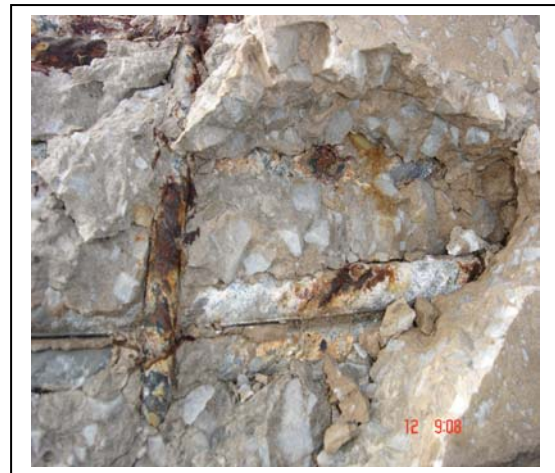
Notwithstanding the findings at the 45 to 60 mm depth of cover, numerous reinforcing bars were found at depths of 15 to 45mm. Even at the reduced concrete cover depths and increased chloride levels, the hot dip galvanized coating was continuing to protect the reinforcing bars. In certain isolated cases where the corrosive conditions had penetrated to the steel, due to very limited cover, the zinc had been sacrificed and some attack was evident of the carbon steel.

Isolated red rust was found, usually associated with minimum concrete cover and/or mechanical damage to the concrete cover.

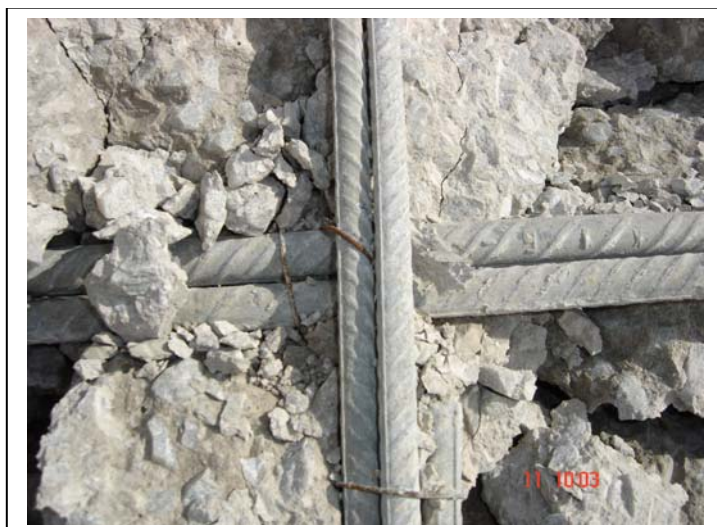
Condition of exposed hot dip galvanized reinforcement found during the demolition of the 20 year old approach stairway. With isolated exceptions, the hot dip galvanized reinforcing shown, in this photograph, is typical of 98% of that inspected.

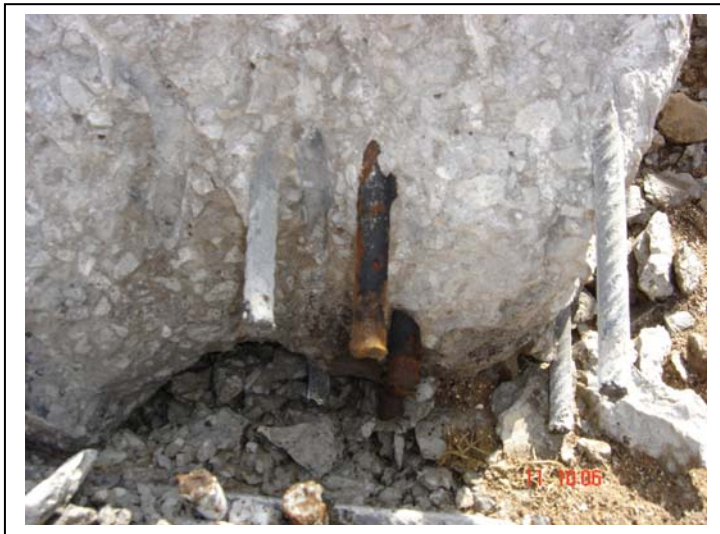
This photograph shows two uncoated reinforcing bars that were used in the stairway without being hot dip galvanizing. The corrosive attack is clearly evident, while the hot dip galvanized bars located alongside are performing with complete satisfaction.

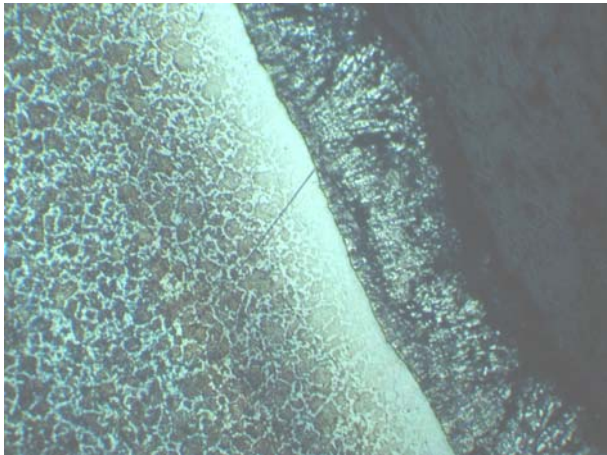
A transverse cross section through the bar revealed a 'normal' galvanized zinc skin with the constituent sub-layers clearly delineated (Figures 1 and 2). The galvanized skin thickness was 240-260 μ m.

**Figure 1.
Galvanized layer (70 to 90µm)
on the reinforcement bar
(100X).**

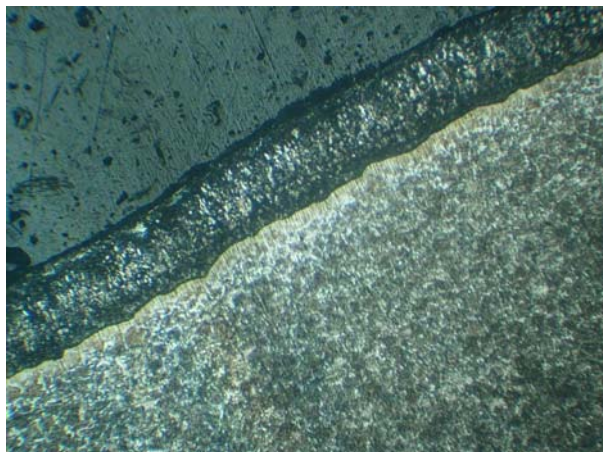
**Figure 2.
Galvanized layer on the
reinforcement bar 45 to 50 mm
cover. (100X)**
