Give us Moor Galvanizing - 20 years of Tropical Mooring

The Breakwater Marina Townsville is constructed of galvanized reinforcement and celebrates twenty years of service and its time for us to inspect the performance of the original galvanized steel.

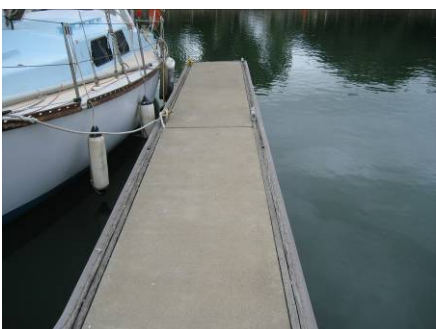
The pontoon structures use galvanized steel mesh and bars which lay over polystyrene floatation cells encased in concrete. Inside these pontoons there are conduits which carry power and fresh water to each mooring and also provide the power for the security lighting. These pontoons are held in position by steel hoops around concrete rendered piles and these hoops are fitted with alignment rollers. The design of the pontoons results in the galvanized components and the top cement surface being within 1 metre, and in some cases within 0.3m of the tropical sea water. For galvanized steel, this environment is classified as severe as per ISO and Australian Standards given the temperature, rainfall, humidity, prevailing winds, cyclone exposure and the proximity to the sea.
