Australian Parliament House Predicted life 100 years and will be exceeded because of Hot Dip Galvanized Steel Reinforcement in Concrete

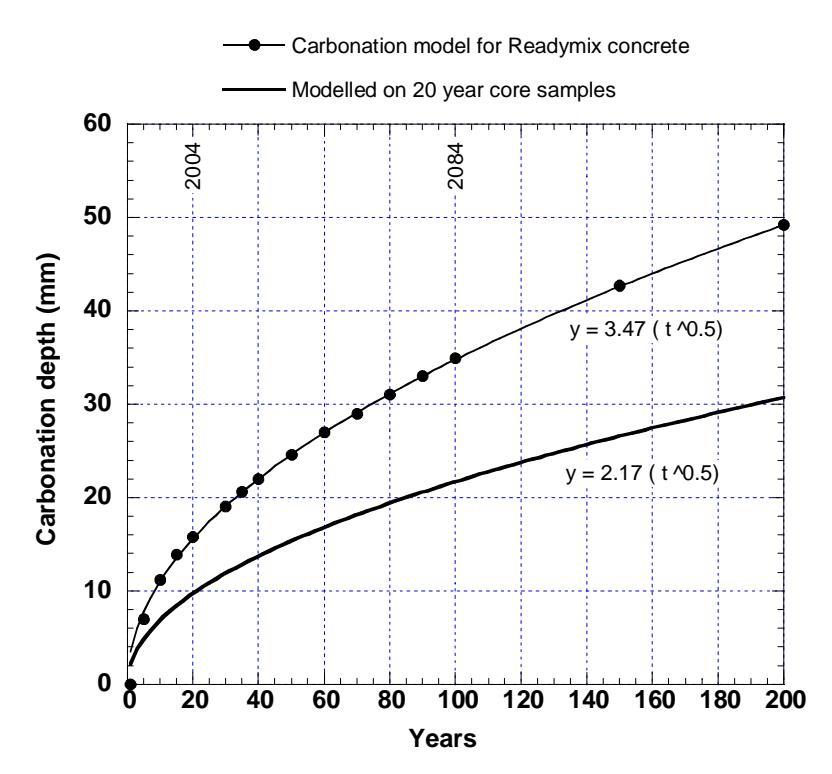
Figure 3: Carbonation rates for the Australian Parliament House concrete [5]

The coring of the concrete results indicated the depth of accumulated carbonation rate to be in the range of 5 to 10mm for the 20 years. This level is significantly lower than the original carbonation model. Based on the single sample after 20 years, the predicted carbonation rate has been plotted in Figure 3 and the difference in the expected durability is significant.

From the graph and measuring the concrete cover, the onset of corrosion is expected at ~130 years (40mm cover) for the Senate building and ~80 years (31mm cover) for the HOR Parliament
