**ZE-341**

**FURTHER STUDIES OF THE  
COMPARATIVE PROPERTIES AND BEHAVIOUR OF  
GALVANIZED AND  
EPOXY COATED STEEL REINFORCEMENT**

**1989 Annual Report  
Progress Report No. 4  
ILZRO Project ZE-341**

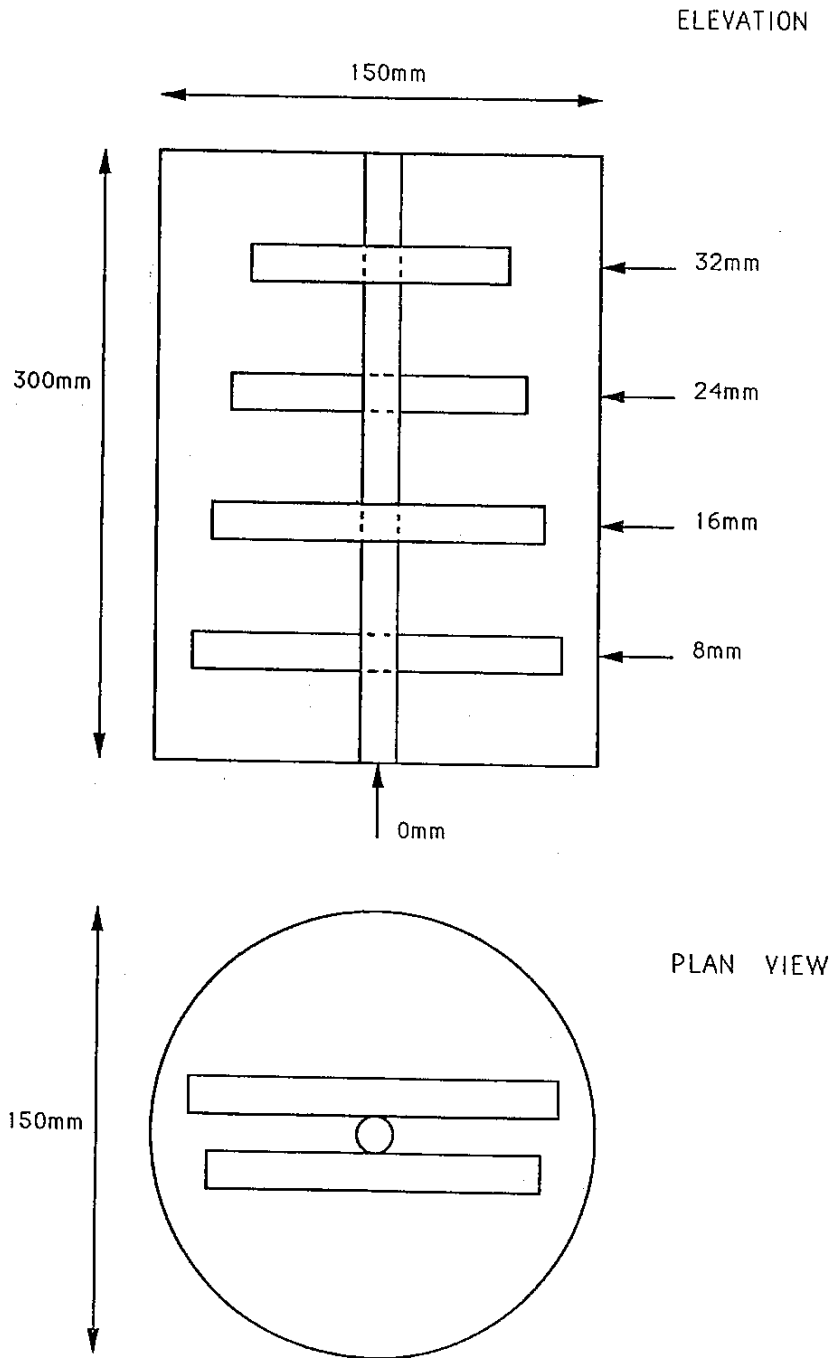
Figure 1: Details of reinforcement frame in accelerated corrosion samples.

In preparing the reinforcement for the specimens, sections were cut to the required length and the reinforcement frame was wired together. Insulating tape was used to isolate each piece from the others in the frame, and stainless steel tie wire was used. On completion of the reinforcement 'tree', one end of each cut piece of coated reinforcement was treated in the recommended manner with an appropriate repair compound. The epoxy coated reinforcement was repaired using 3M SCOTCHKOTE<sup>R</sup> 213PC patching compound while the galvanized coating was repaired with GALVIT E90, a heavy duty cold repair zinc-rich priming paint.

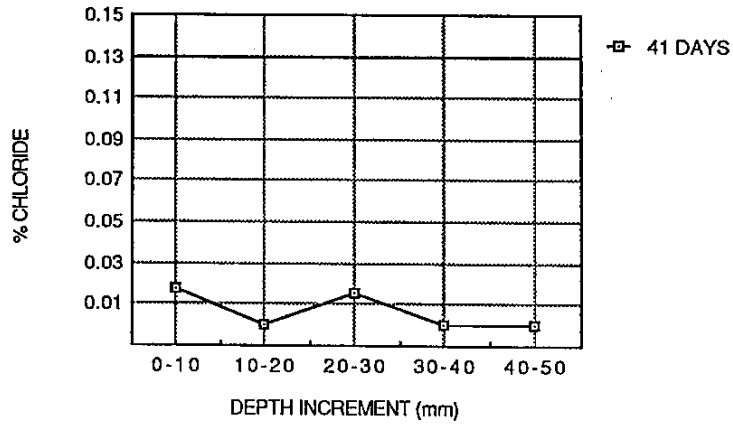
Figure 2: Chloride penetration profile for 41 day atmospheric exposure (Sample RB4).

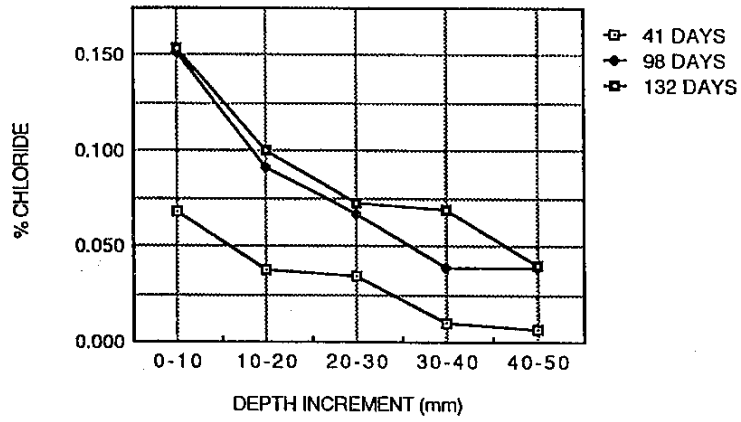
Figure 3: Chloride penetration profiles from salt fog exposure for 41, 98 and 132 days (Samples BB10, BB11 and BB12 respectively).

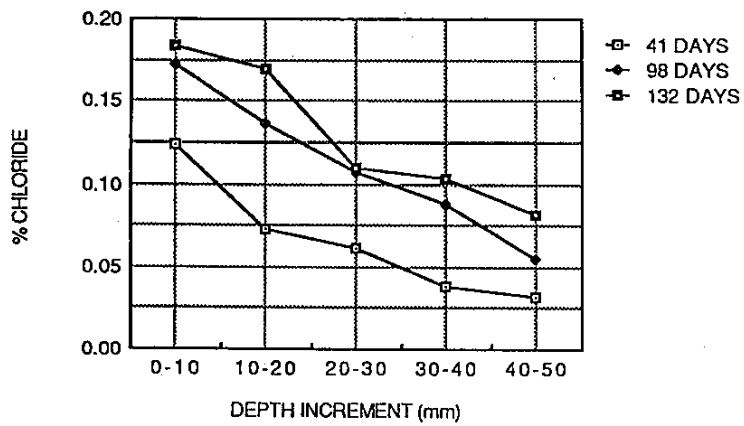
Figure 4: Chloride penetration profiles from wet and dry salt water exposure for 41, 98 and 132 days (Samples OB7, OB8 and OB9 respectively).

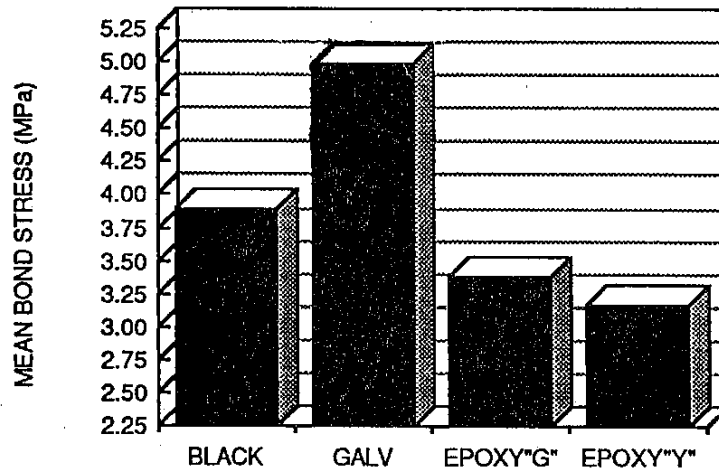
Figure 5: Comparison of ultimate bond stress of black steel and coated plain steel reinforcement.

A summary of the results of the pullout testing of plain bars is given in Tables 3 and 4. The bond stress is calculated as the failure or maximum load divided by the contact area of length of the embedded reinforcement. The mean value and the standard deviation are calculated from the three individual results given. In Table 3, the comparative pullout performance of black, epoxy coated, and galvanized plain steel bars is given. The effect of various levels of chromate ion additions to the concrete mix water on the pullout strength of galvanized plain steel reinforcement is given in Table 4.

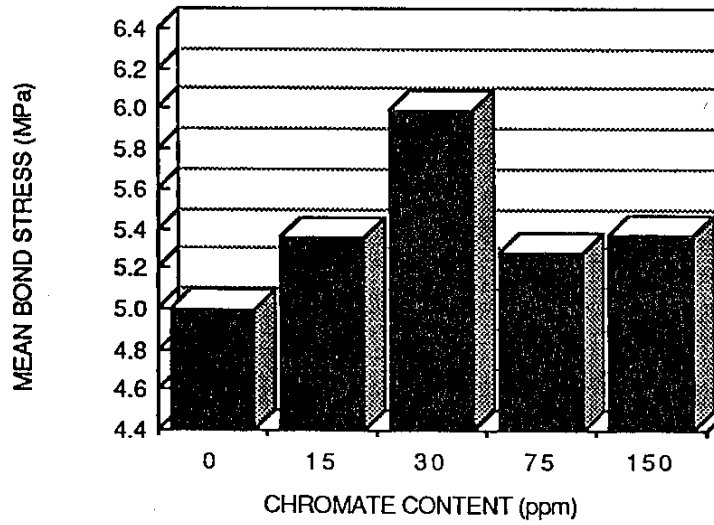
Figure 6: Showing the effect of chromate additions on the ultimate bond stress of galvanized plain steel reinforcement.

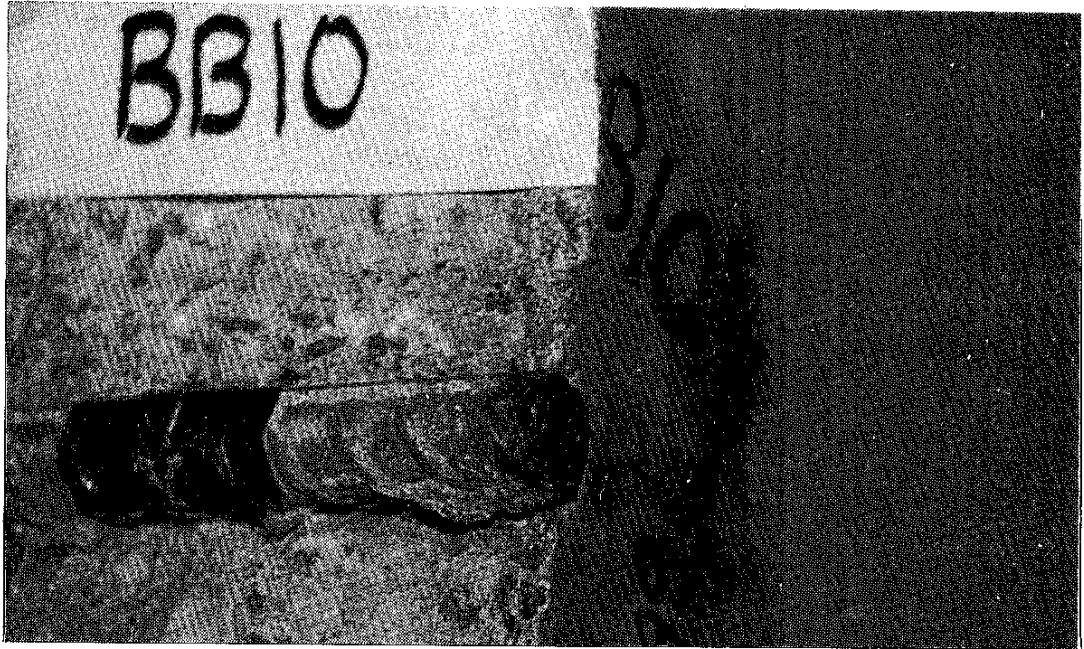
Plate 1: Sample BB10: Black Steel - Salt Fog - 41 Days.  
Corrosion activity on exposed end (0 mm cover) of longitudinal bar.

There was increased corrosion activity on the exposed bar (0 mm cover) and this had progressed to a maximum of some 15 mm from the free surface (see Plate 1). Similar attack had initiated at the ends of the section with 10 mm cover where localized points of red rust corrosion were present.

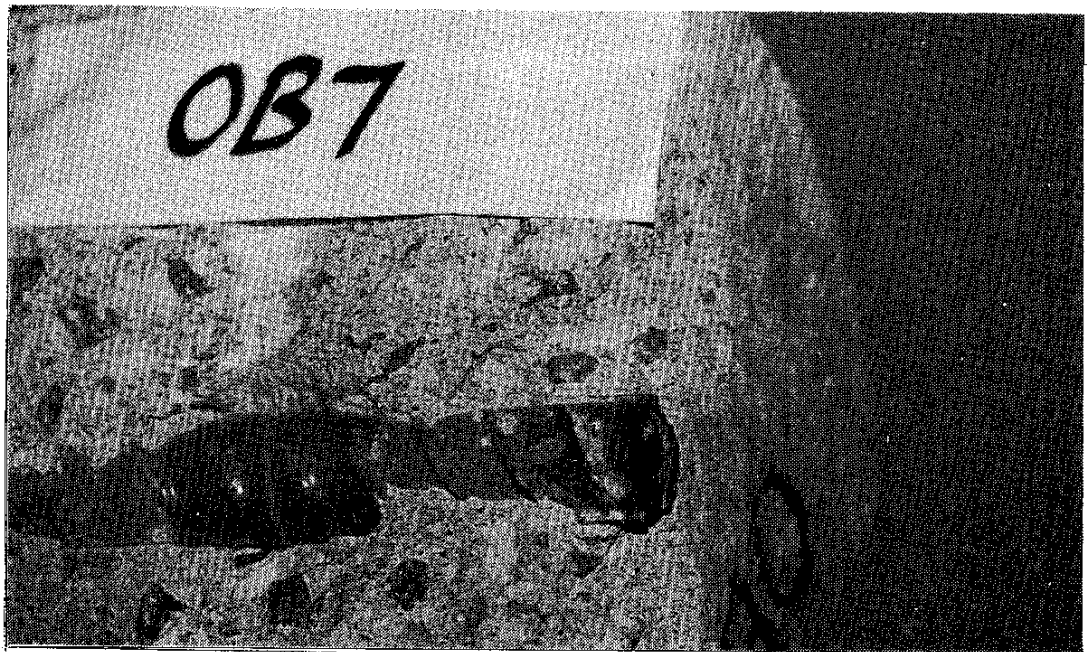
Plate 2: Sample OB7: Black Steel - Wet and Dry - 41 days.  
Corrosion activity progressing some 13 mm from the exposed end of the longitudinal bar.

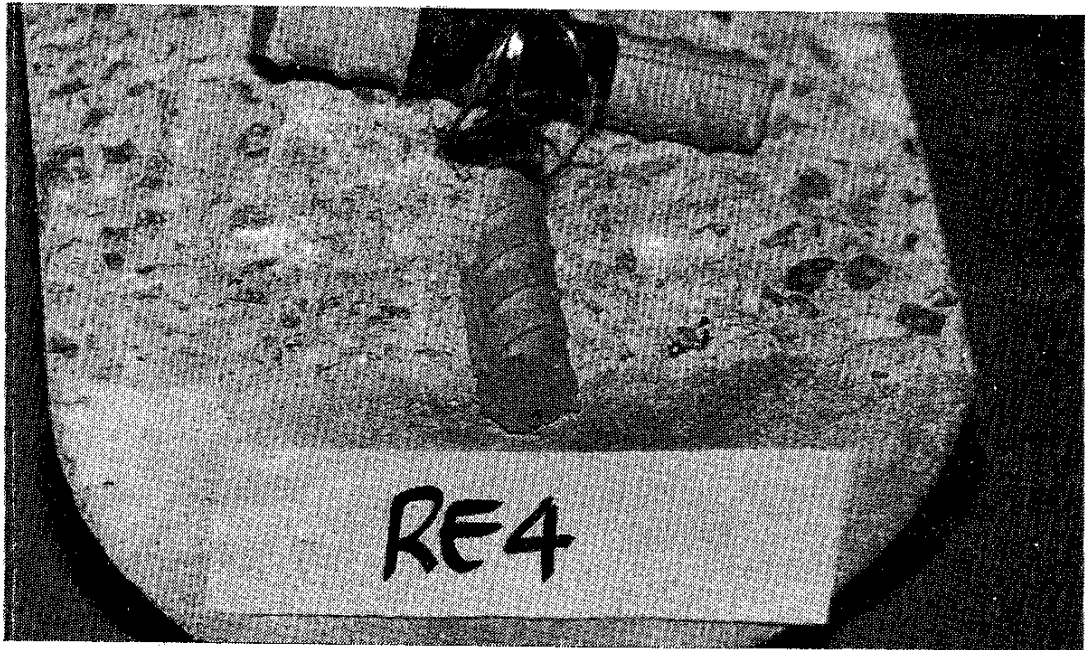
Plate 3: Sample RE4: Epoxy Coated Steel - Atmosphere - 41 Days. Localized corrosion at repaired exposed end of longitudinal bar.

The epoxy coated steel showed general attack at the exposed (0 mm cover) unrepaired end, and also exhibited localized pitting attack at some 7 locations of failure of the repair compound at the opposite end of the exposed bar (see Plate 3). Apart from this there was no sign of corrosion at any location of reinforcement within the concrete mass, including those sites where the cut ends were not repaired.

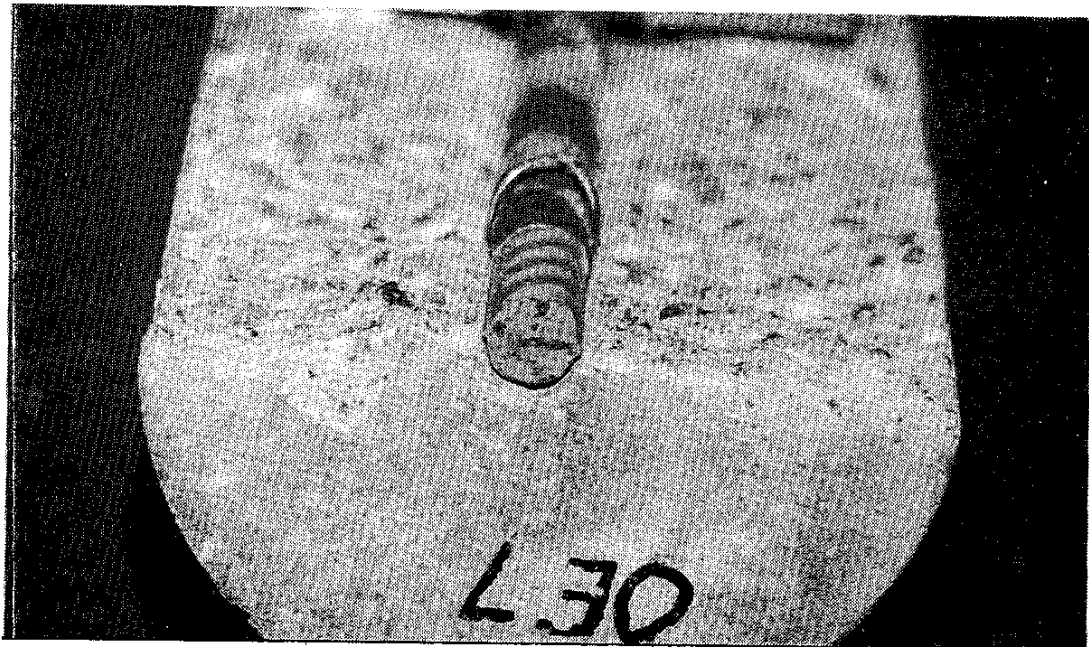
Plate 4: Sample OE7: Epoxy Coated Steel - Wet and Dry - 41 Days. Localized corrosion at repaired exposed end of longitudinal bar.

The epoxy coated steel was severely corroded at the exposed unrepaired end, and there was some evidence that corrosion was progressing along the bar beneath the coating. At the exposed (0 mm cover) repaired end of the bar, there were some 13 locations

where localized corrosion was evident (see Plate 4). On bars with concrete cover of 15-20 mm, rusting of the cut end was evident and the opposite repaired end was showing distress to the coating. Elsewhere at greater depth in the concrete, the reinforcement was intact including cut ends which had not been repaired.

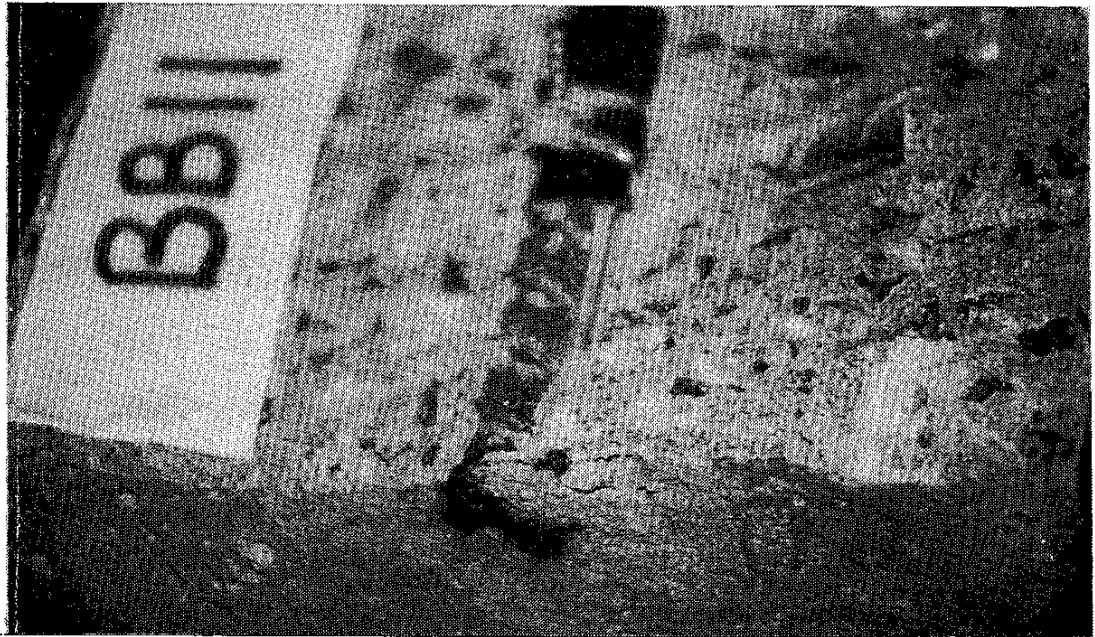
**Plate 5:** Sample BB11: Black Steel - Salt Fog - 41 Days.  
Corrosion progressing along the bar from the exposed end of longitudinal bar.

There was extensive corrosion of the exposed ends of the black steel bars in the salt fog regime, this attack extending some 15 mm along the bar below the concrete surface (see Plate 5). On bars with approximately 25 mm cover to the cut ends, some slight red rust corrosion was also in evidence.

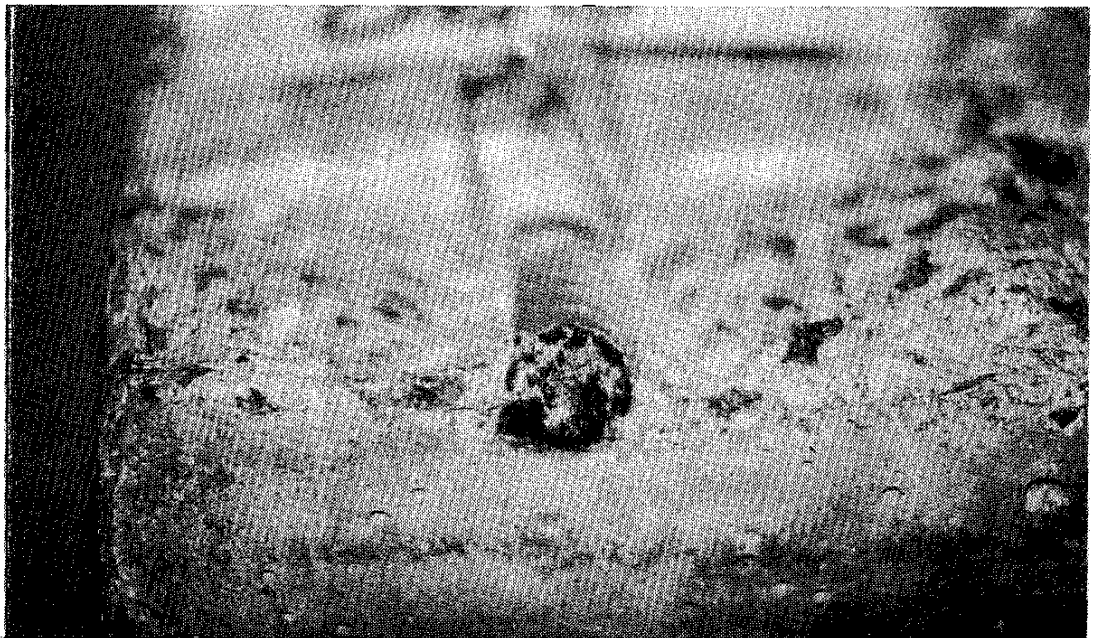
**Plate 6:** Sample OE8: Epoxy Coated Steel - Wet and Dry - 98 Days.  
Corrosion at unrepaired exposed end of longitudinal bar.

Corrosion was well progressed on both ends of the exposed bar (see Plate 6), and was also evident at both ends (repaired and unrepaired) of bars with covers in the 10-20 mm range (see Plate 7). On the bars at depth in the concrete, the corrosion was localized in this early stage of attack,

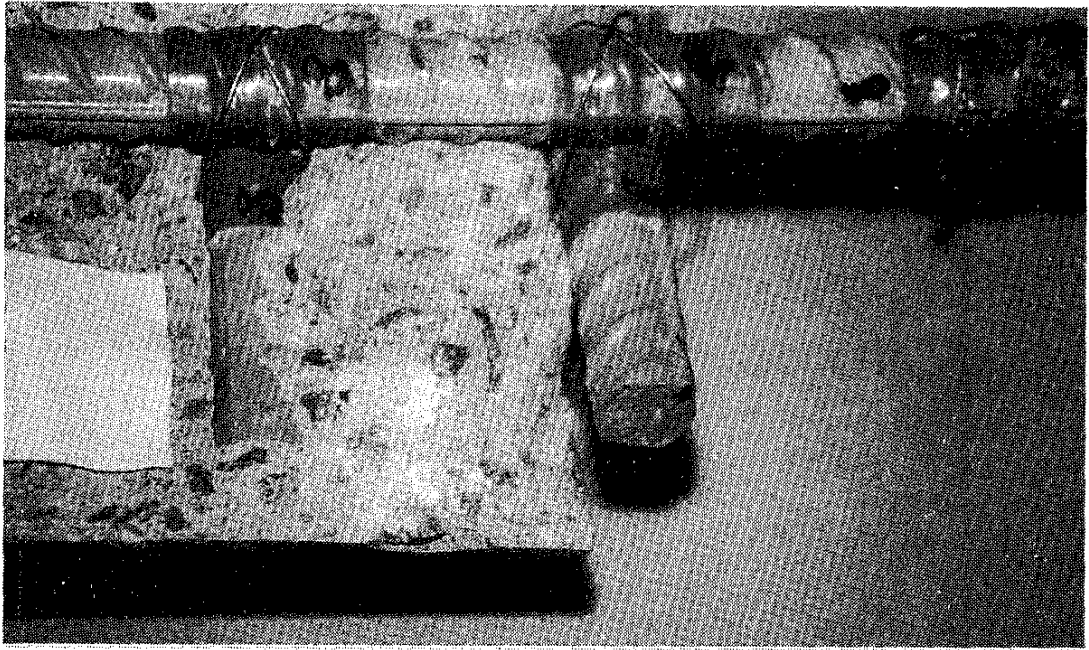
Plate 7: Sample OE8: Epoxy Coated Steel - Wet and Dry - 98 Days. Localized corrosion activity at repaired end of the bar with 8 mm cover.

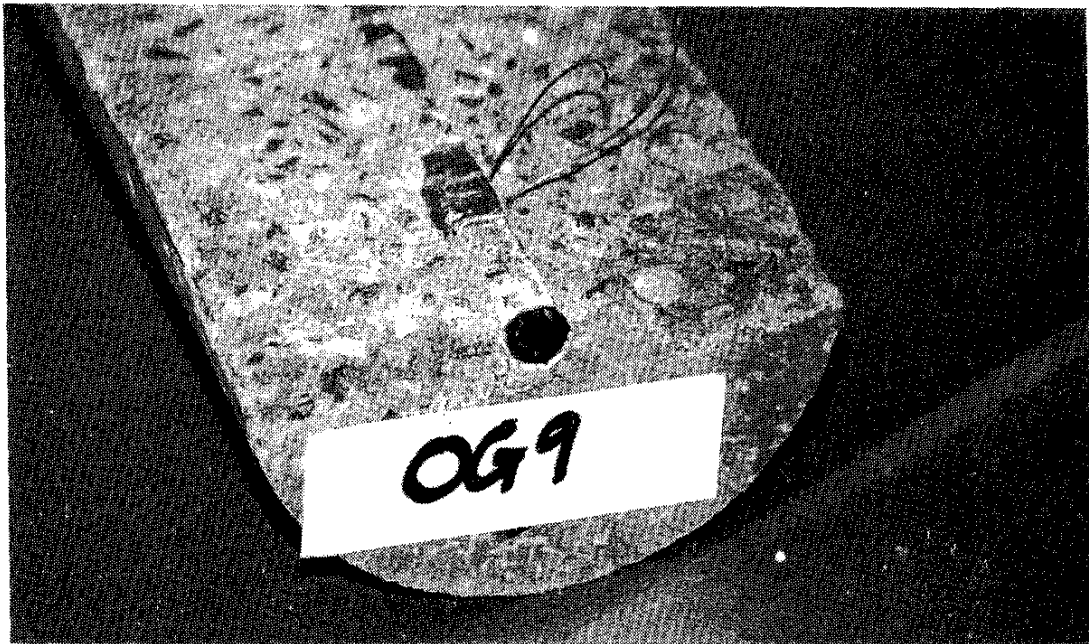
Plate 8: Sample OG9: Galvanized Steel - Wet and Dry - 132 Days. General corrosion at unrepaired exposed end of longitudinal bar also showing white zinc reaction product.

The unrepaired end of the exposed bar was corroded (see Plate 8) though elsewhere no red rust corrosion was evident. White zinc reaction product was evident around both ends of the exposed bars. All the bars at depth in the concrete showed varying degrees of white product at their surface. Bars with 10 mm cover showed white product up to 55 mm from the unrepaired end and 30 mm from the repaired end. Bars with 30 mm cover also showed some white zinc reaction product over a significant portion of their length (see Plate 9). No red rust was present at any site on the reinforcement frame.

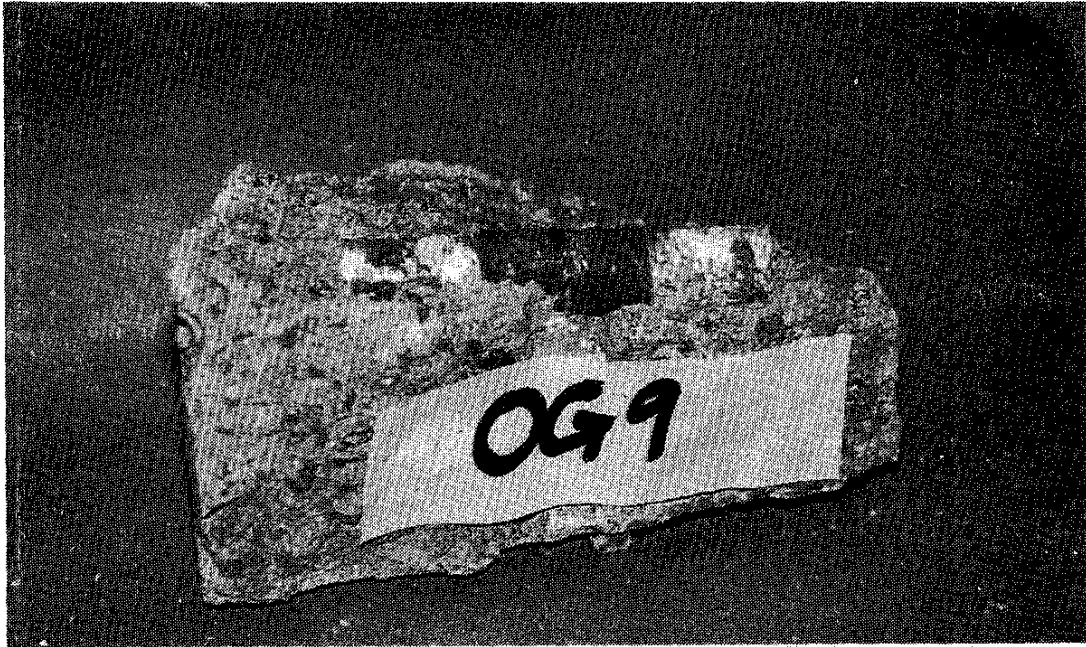
Plate 9: Sample OG9: Galvanized Steel - Wet and Dry - 132 Days. White zinc reaction products on bar with minimum cover at ends of 32 mm.

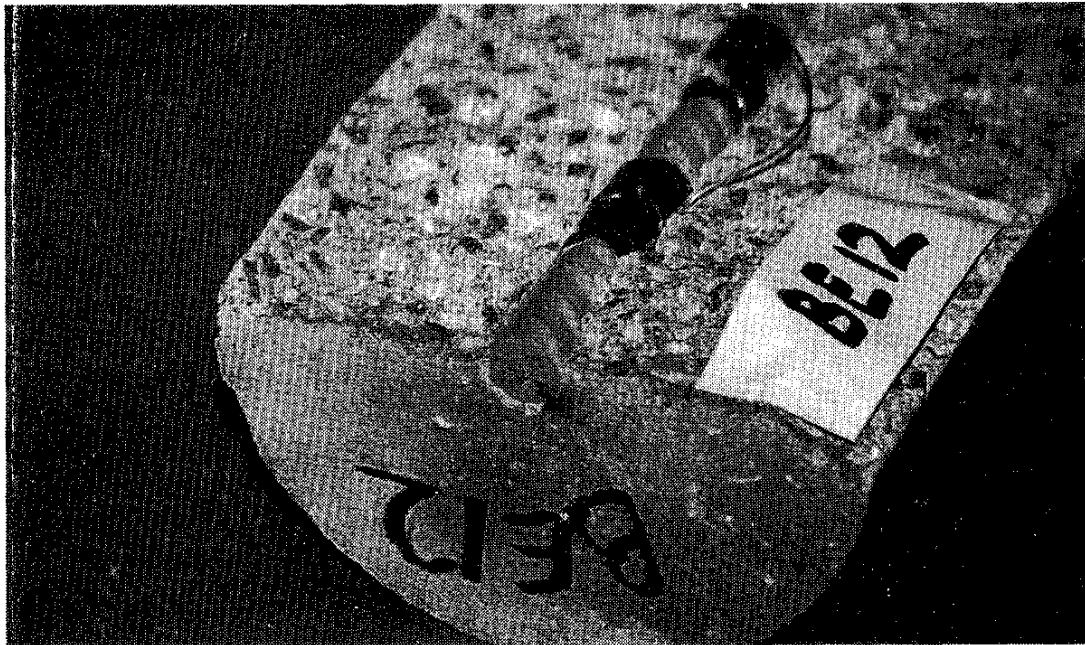
Plate 10: Sample BB12: Epoxy Coated - Salt Fog - 132 Days. Localized corrosion at repaired exposed end of longitudinal bar.

Both the repaired and unrepaired ends of the exposed (0 mm cover) epoxy coated bar were corroded (Plates 10 and 11). The general condition of the reinforcement within the concrete was good, except for the repaired end of the bar with about 30 mm cover (see Plate 12).

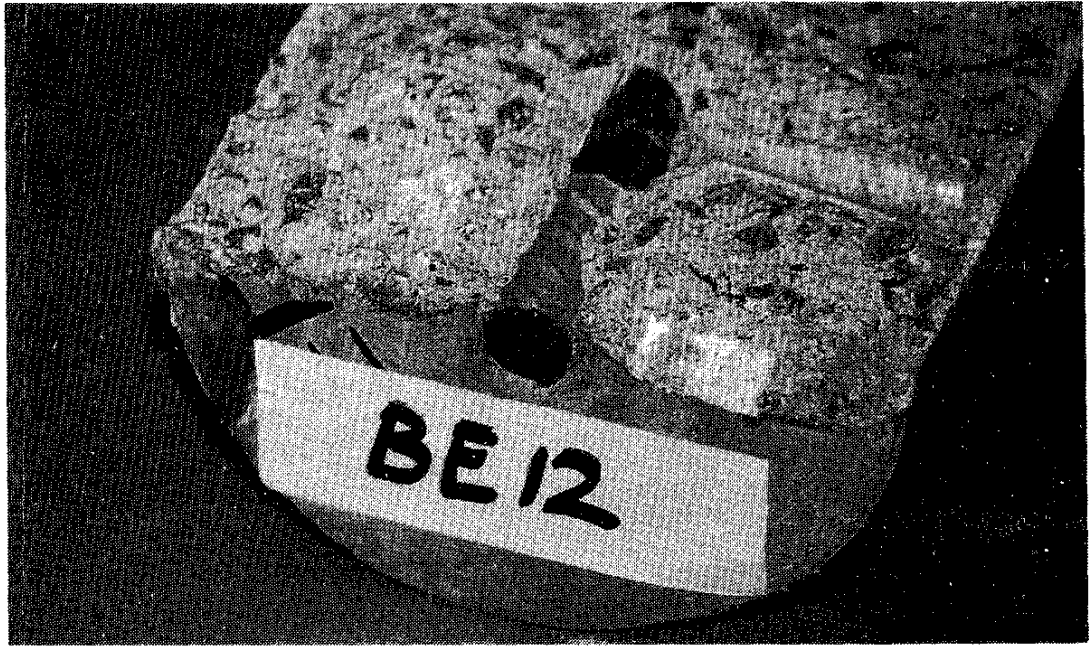
Plate 11: Sample BE12: Epoxy Coated - Salt Fog - 132 Days.  
General corrosion at unrepaired exposed end of longitudinal bar.

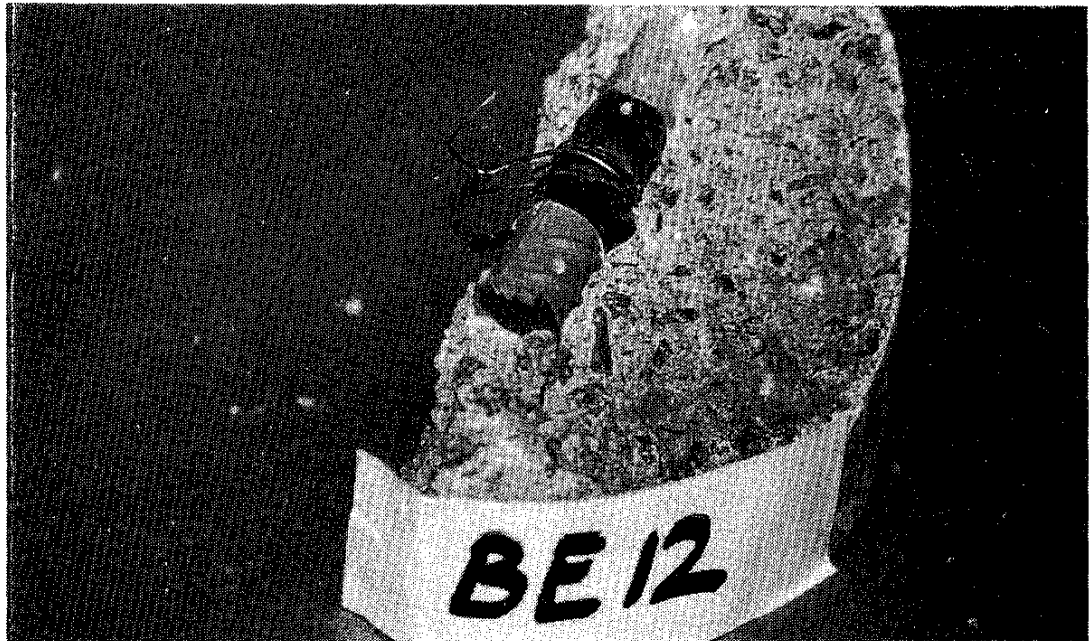
Plate 12: Sample BE12: Epoxy Coated - Salt Fog - 132 Days.  
Corrosion activity at repaired end of bar with 32 mm cover.

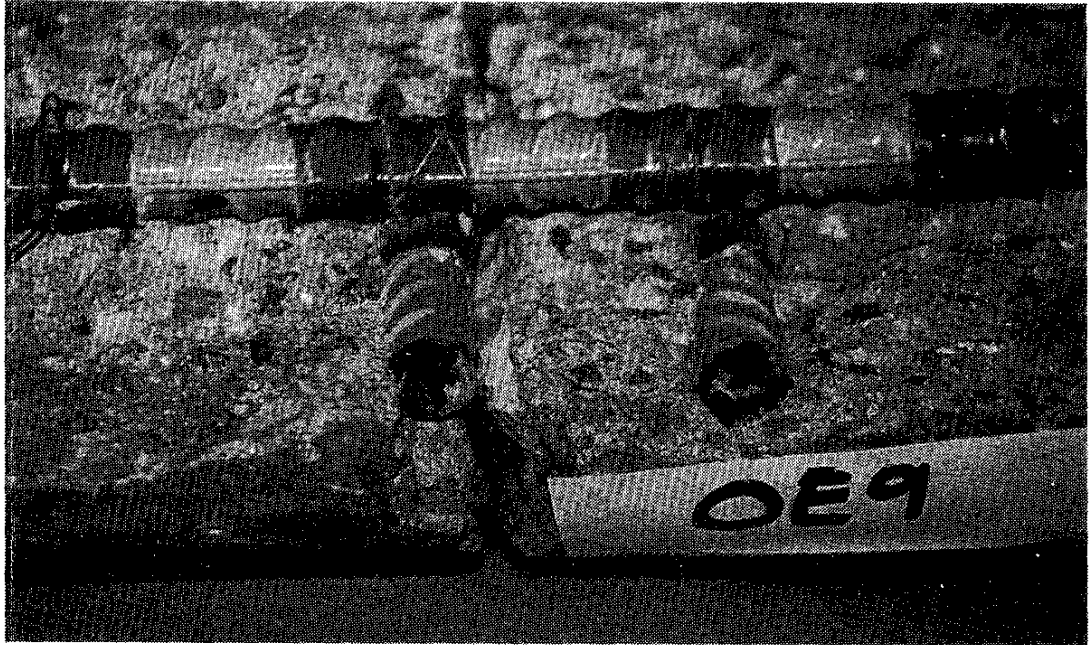
Plate 13: Sample OE9: Epoxy Coated - Wet and Dry - 132 Days.  
Corrosion at unrepaired ends of bars with covers of 16 mm  
and 22 mm.

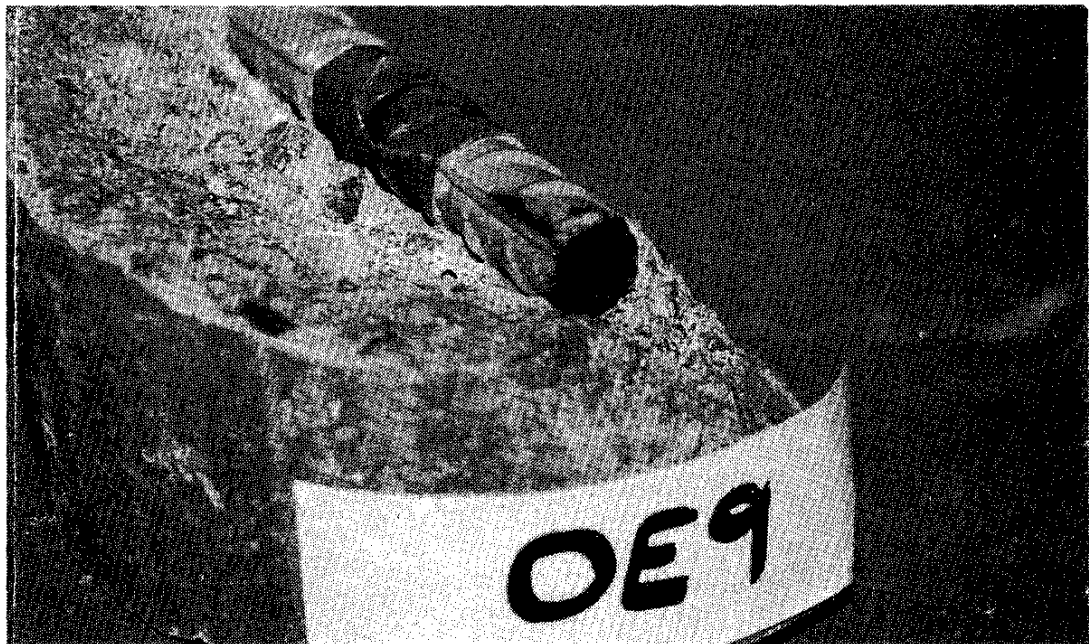
Plate 14: Sample OE9: Epoxy Coated - Wet and Dry - 132 Days.  
Corrosion at unrepaired end of bar with 32 mm cover also  
showing localized attack along the bar away from cut edge.

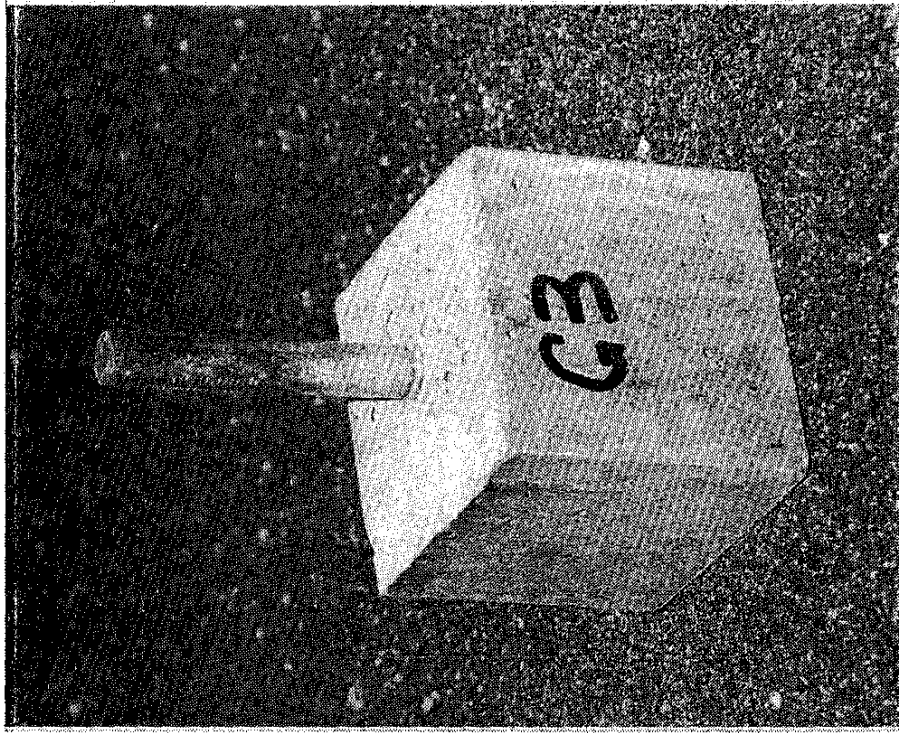
Plate 16: Slippage of bars in pullout testing with plain bars.

The mode of failure of the pullout specimens was dependent on the nature of the reinforcement itself. While there was no difference in the failure of specimens with different surface coatings, there was an effect depending on whether or not deformed or plain bar was used. All of the plain reinforced specimens failed by slippage of the bar with little or no disturbance to the concrete mass. In contrast, deformed (i.e. ribbed) bar specimens from previous work all failed by splitting of the concrete. These differences are shown by the representative specimens in Plates 15 and 16.

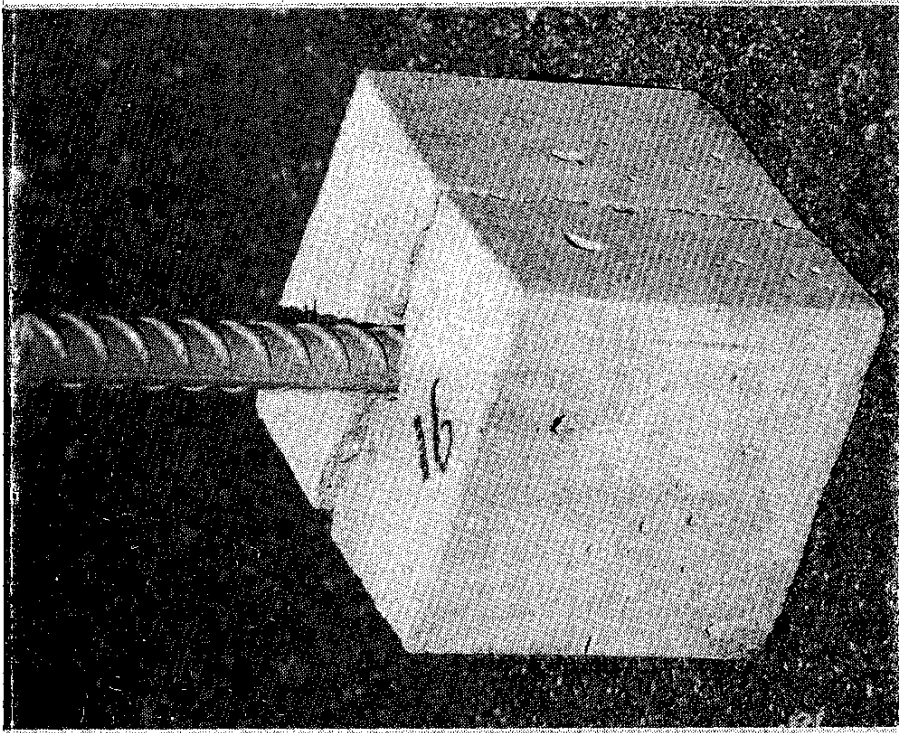
Plate 15: Splitting failure of pullout specimens with deformed bars.
