Research and Update on Galvanized Reinforcing Steel

Thomas J. Kinstler
Industrial Galvanizers America
Midlothian, Virginia

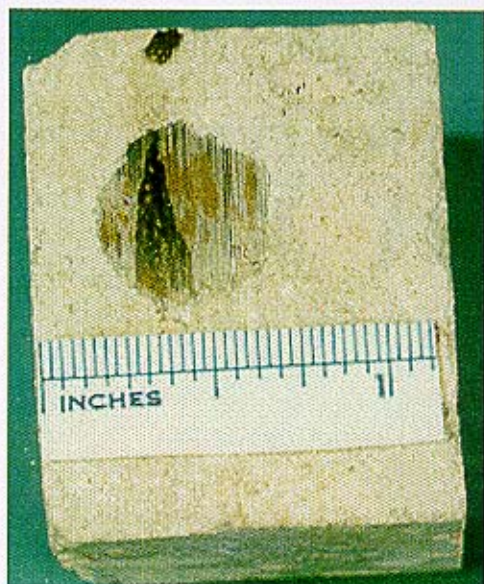
Figure 3 – Core #1

Figure 3 shows an “as-received” section of core #1 which contained a relatively smaller rebar, and Figure 4 show an “as-received” section of core #2 containing a relatively larger rebar segment. Note that the small amount of iron corrosion product on the “face” of the rebar in core #1 is the result of sea water being used as the core drill coolant. Virtually no iron corrosion products were found at the bar-concrete interface, and no cracks or other distress was seen as a result of whatever zinc corrosion had occurred. Figures 5 and 6 show the extracted small rebar from core #1, Figure 5 is the side of the bar “away” from the advancing

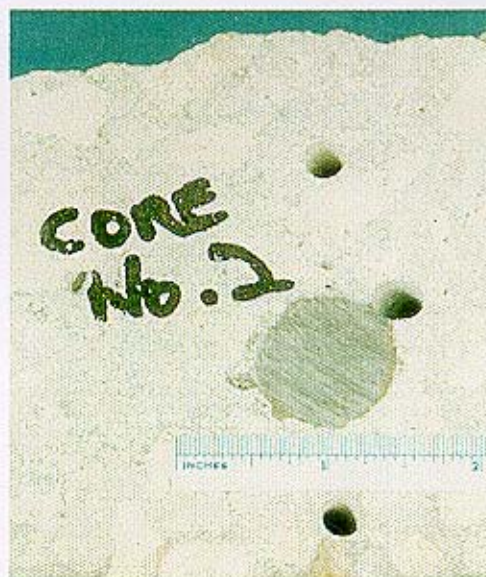
Figure 4 – Core #2

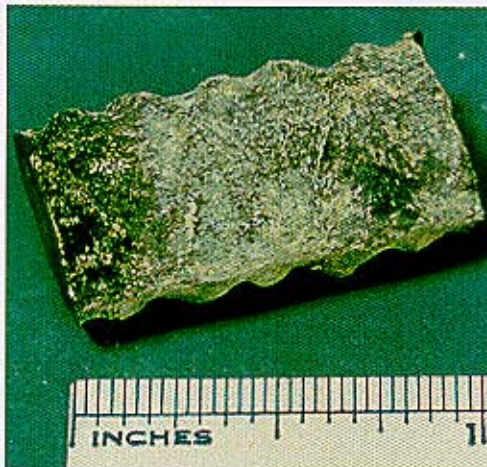
Figure 5 – Core #1 Bar “Away”

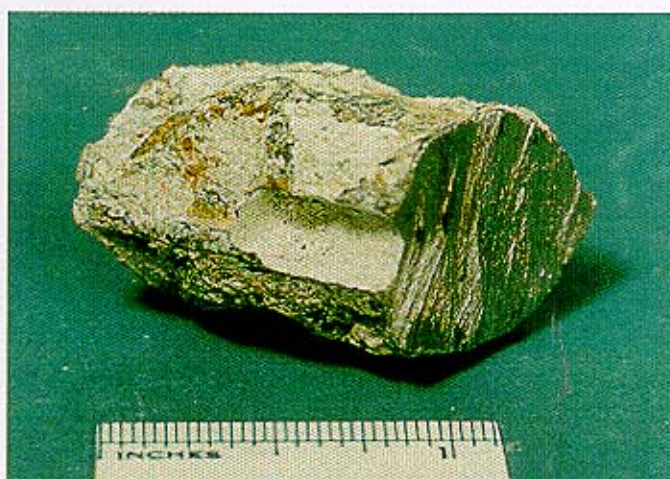
Figure 7 – Large Bar from Core #2

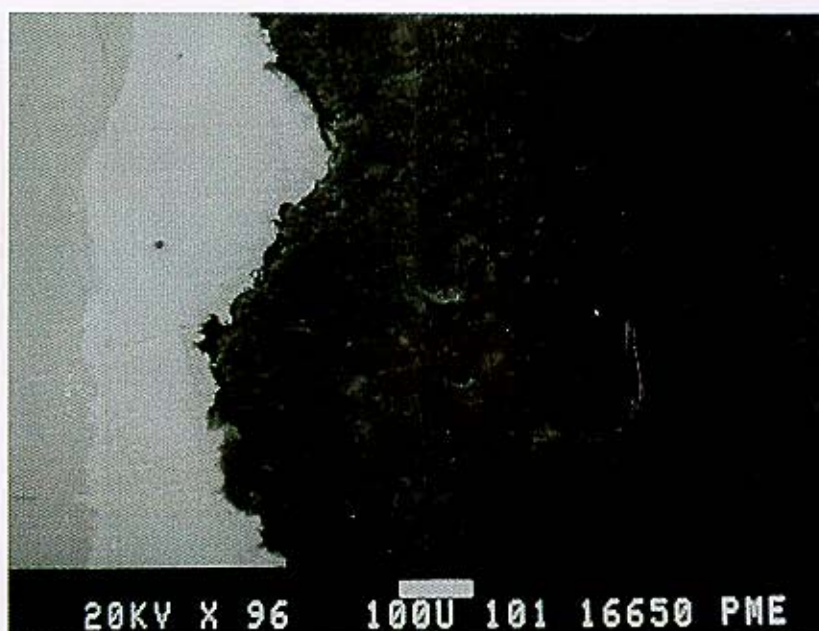
Figure 10 – SEM Photo of Bar/Coating/Concrete Interface of Bar #1

A section of core #1 was taken to examine the steel bar/coating/concrete interfaces by SEM, and to study the distribution of elements along that continuum. Figure 10 shows the interfacial area – the light gray zone at the far left of the photo is the underlying steel, the off-white area is the galvanized coating, and the dark area which occupies most of the photo is the concrete. This, as well as all other photos of the interfacial area showed no cracking of the concrete regardless of the amount of corrosion which might have taken place. Figure 11 is the elemental map (zinc, iron, calcium, and silicon) of the area shown in Figure 10. For clarity, silicon was not included in the composite on the right of Figure 11.

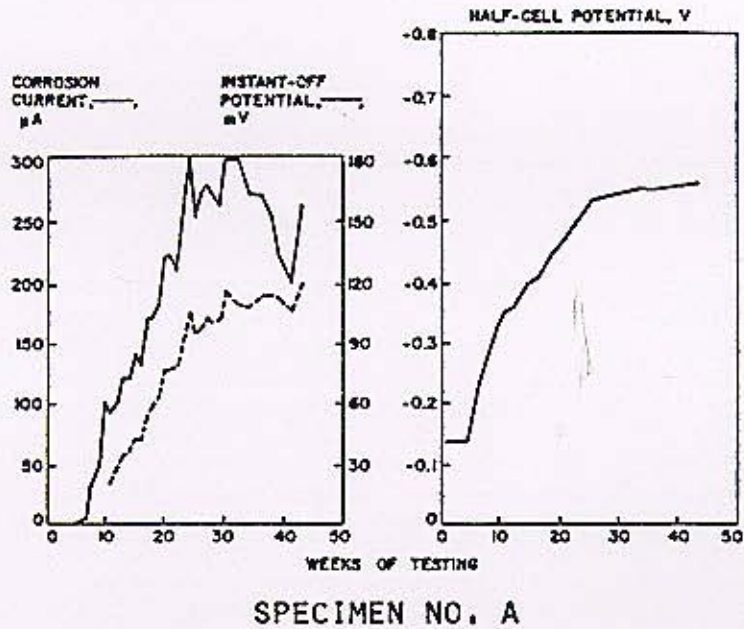
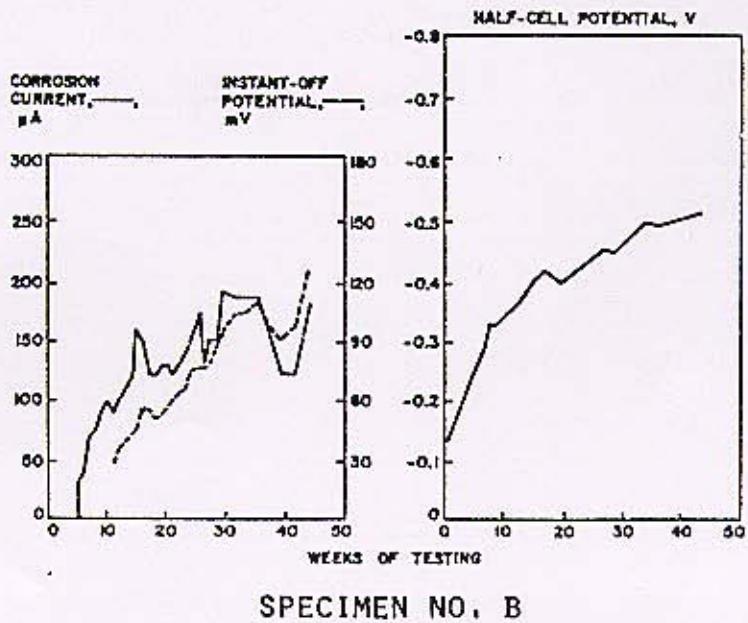
Figure 12 – System 1 - Black Bar Both Mats (from Pfeifer et al)

Three observations are notable from comparison of Figures 12 and 13. First, the half-cell potentials for the black steel bars rises rapidly after a short period, and continues to rise over the test period. This potential shift coincides with a dramatic rise in corrosion current and is

most likely indicative of the arrival of the chloride permeation front. Second, roughly midway through the first 10 week period, the galvanized steel bars show a potential shift, however after reaching a peak over the next 20 week period, the potential reversed towards the original levels. The measured corrosion current went through a similar (but shallower) rise and fall during the period of the potential shift and reversal, returning to essentially the value at the start of the test. Third, at the later stages of the test period, the corrosion currents for the black steel bars varied either side of 160 – 250 μA midpoint, while the corrosion current for the galvanized bars in similar conditions were negligible in a chloride environment which is corrosive to black steel. The rise of current at the arrival of the chloride permeation front, followed by a return to low corrosion current levels suggests a value to an “active” coating which responds to the chloride corrosion stimulus in an almost “biological” way.

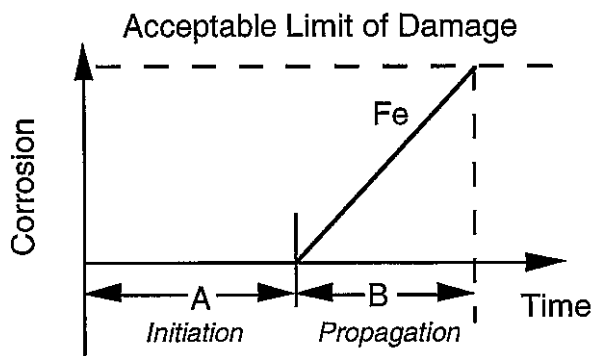
Figure 15 – “Tuutti” Diagram Rates (a,b,c)

Figure 15 shows that the corrosion of metals imbedded in concrete is often preceded by a dormant period as a result of the passivating effect of the concrete internal environment on the metal, which has often been called the “initiation” period labeled in Figure 15 as time period “A.” The term “initiation” also refers to the time during which external corrosion stimulators are diffusing or permeating into the concrete matrix to ultimately “initiate” a corrosion response. It is in fact the period prior to “initiation” of active corrosion. At some point in time, if the local metal/concrete interface changes due to permeation of activating species from the concrete surface, the previously dormant surface may “depassivate” and enter a corroding state often termed the “propagation” period, the rate of which depends on the interrelated equilibria and kinetics at the interface.

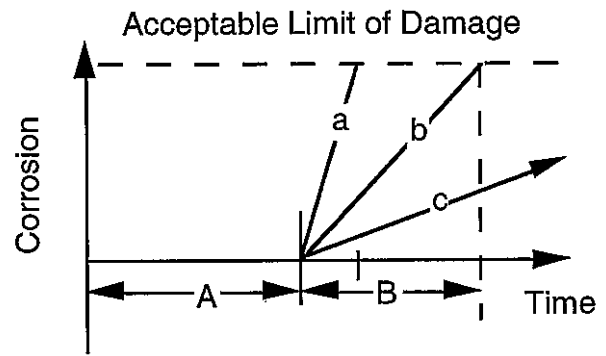
Figure 16 – Various Corrosion Rates (a,b,c)

Figure 16 depicts various degrees of corrosion “propagation”, as time period “B”, with “a” being a higher, and “c” a lower corrosion rate. The result of these corrosion intensities may be (but is not always) the deposition of solid corrosion products, the volume of which (to the extent that they are not mobile) exerts a “wedging” action⁵⁵ or “hoop” stress at the interface which, if accumulates to higher than the inherent strength of the matrix, cracks and ultimately spalls the concrete - the point at which the extent of physical damage exceeds some acceptable limit.

While Figures 15 and 16 indicate some relationship between corrosion, damage, and time span in that at some time the degree of corrosion occurred could result in stresses exceeding some acceptable limit of damage, not all metallic materials have the same corrosion/damage/stress/time response relationship. It is important, therefore, to explore:

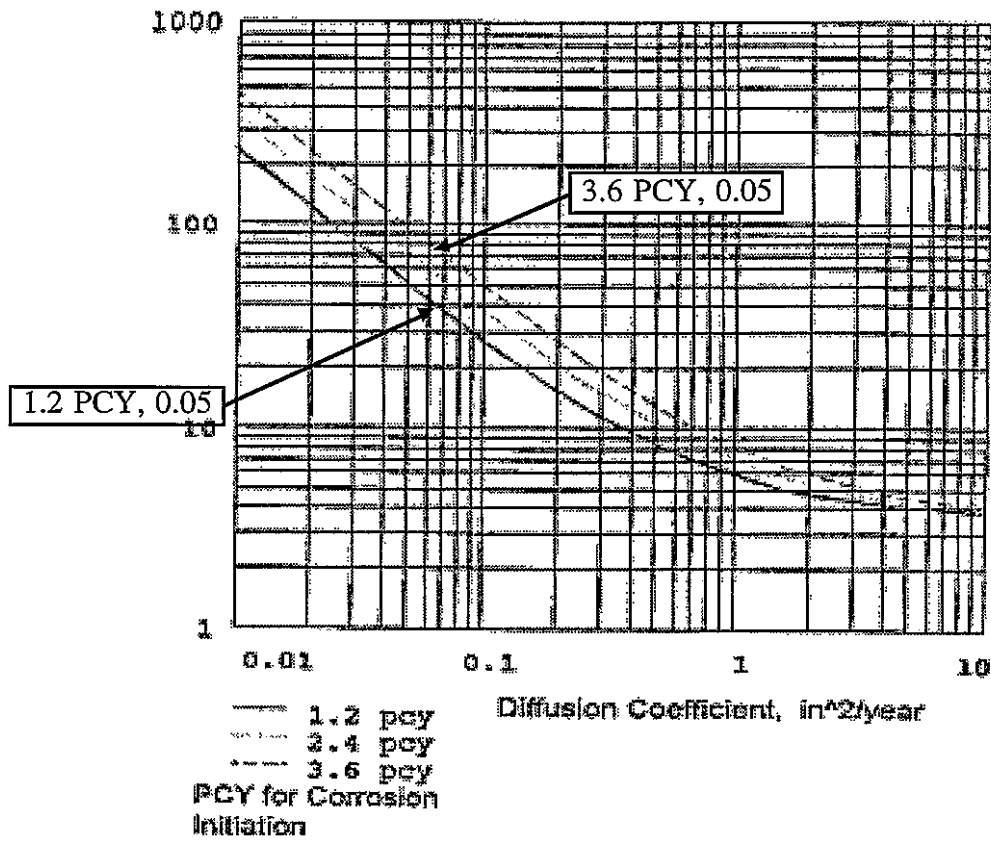
Figure 19 - Years to Spall - 4 inch Cover (adapted from Sagues 1994)

The calculations underlying the diagram in Figure 19 assume a “Propagation” period of 3.5 years (as line “a” in Figure 16). Thus, for all practical purposes, the years-to-spall on the ordinate are effectively years-to-depassivation, at least for long time periods. Given the demonstrated higher critical chloride threshold, it would not be unreasonable to use 3.6 pounds per cubic yard (2.13 kg/m³) for zinc, and at the same chloride diffusion coefficient (0.05 since it is a function of the concrete and not the rebar material) the years-to-depassivation would be just below 100, or just over twice that for uncoated steel.
