# Galvanized Rebar:

Lowest Cost of Ownership in  
Reinforced Concrete Bridges

Sponsored by the International Zinc Association

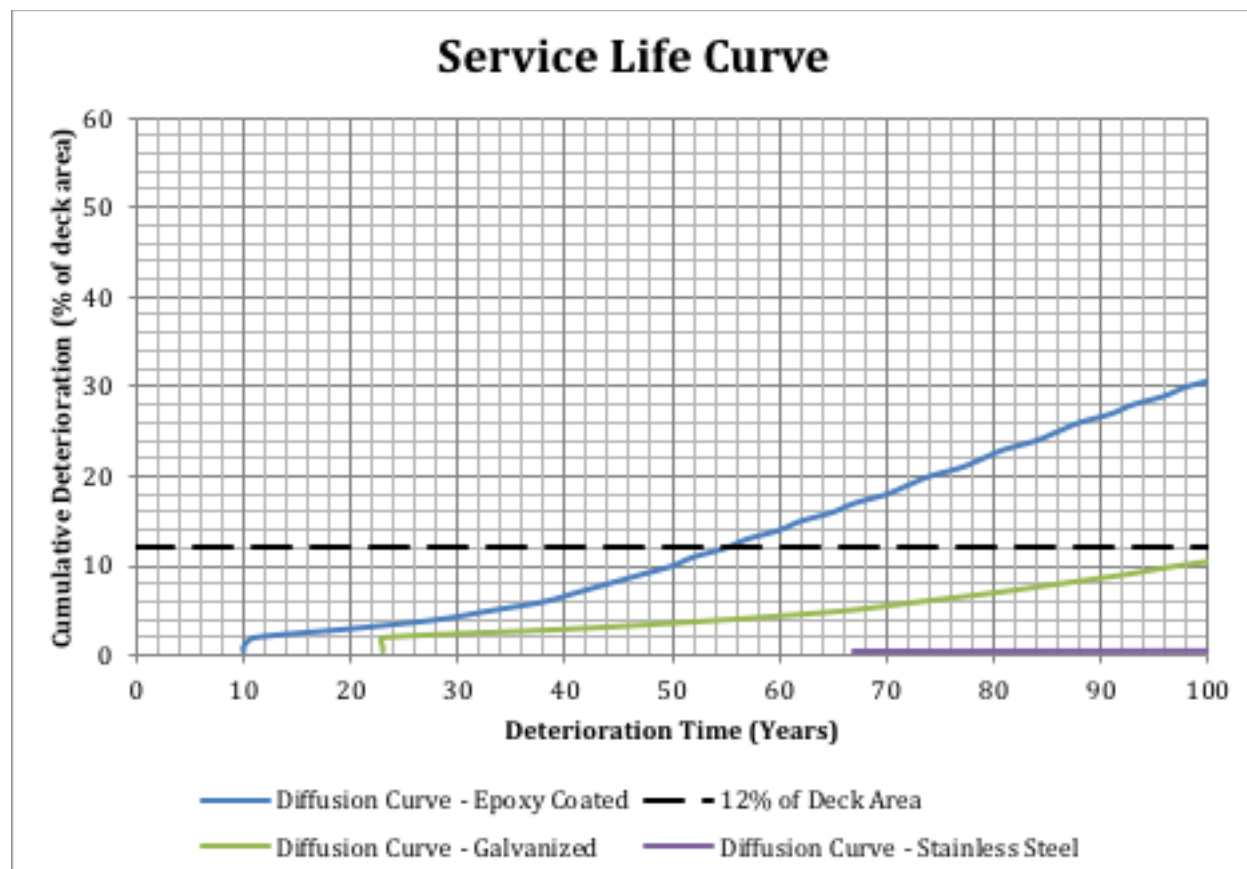
A bridge in Virginia is considered to have reached its maximum service life when 12% of the surface needs patching or repairing. The calculated service life curve for the Northern zone, again for a bridge deck where 6% of the surface area had initial surface cracks, showed that deck replacement is required after 54 years for the epoxy-coated rebar, 109 years for the galvanized rebar, and outside of the 100-year specified life for the stainless steel rebar.

Bridge maintenance is undertaken when 2% of the bridge surface area needs patching or repairing. As an example for the epoxy-coated bar, corrosion initiation with a deck with 6% initial surface cracks begins in the first year. The surface damage of the deck increases to a total of 2% after 11 years, after which the first deck patching will be required. Additional re-patching is required until the end of service life when the deck requires replacement after 54 years.

For galvanized steel, however, 15 years are needed before corrosion of the steel begins so that a 2% damaged area on the surface of the deck is not reached until 23 years. For stainless steel, the time to corrosion initiation is well beyond the design life of the deck, but because of the very high chloride concentration, corrosion begins quickly; however, the time for any repairs is also well beyond the 100-year design life of the bridge.
