FIELD PERFORMANCE OF EPOXY-COATED REINFORCING STEEL
IN VIRGINIA BRIDGE DECKS

Dissertation submitted to the Faculty of the
Virginia Polytechnic Institute and State University
in partial fulfillment of the requirements for the degree of

Civil Engineering

September 4, 1998

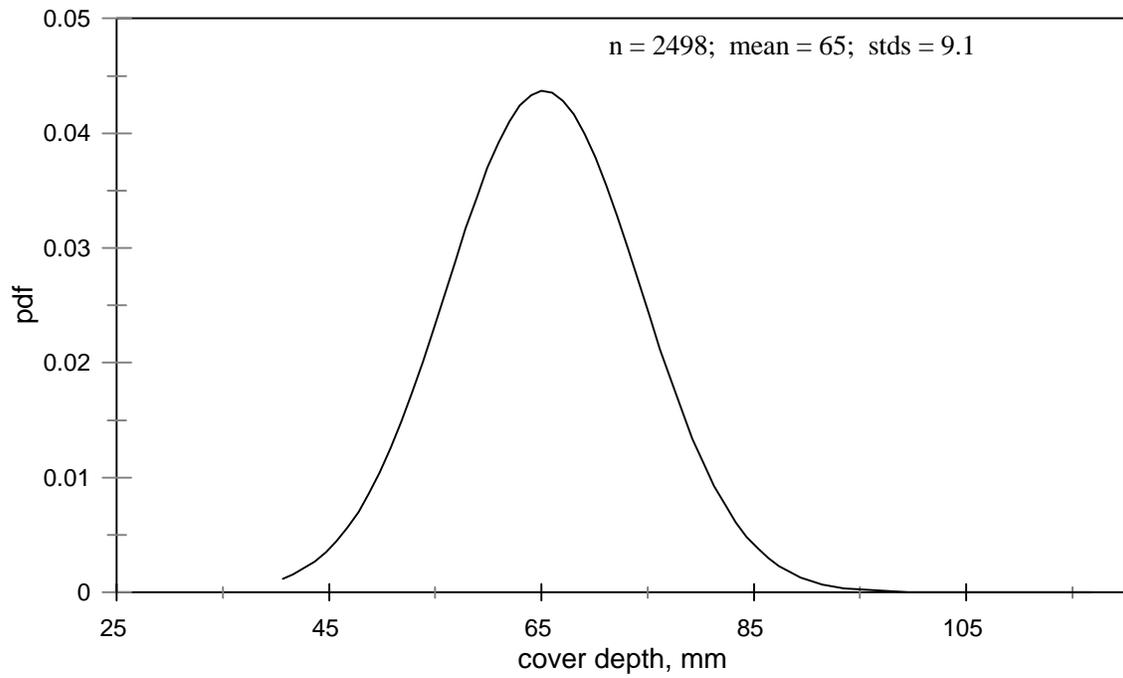
Figure 11.   Cover Depth Measurement Distribution (Phase I and Phase II).

Cover depth measurements for the 21 bridge decks (Phase I and Phase II) were normally distributed with the mean of 65 mm and the standard deviation equal to 9.1 mm, see Figure 11. As shown in Figure 12, 8 bridge decks had an average cover depth between 50 and 65 mm, 9 decks between 66 and 74 mm, and the cover depth for one deck was greater than 75 mm.

Cover depth measurements, obtained from the evaluated concrete bridge decks, were normally distributed with the mean of 65.2 mm and the standard deviation equal to 9.13 mm, Figure 11. They were either slightly below or above the VDOT Hydraulic Cement Specifications of 64 mm clear cover, Figure 12. Only for one tested structure, SN6005 (1989), was the measured cover depth higher than 75 mm.

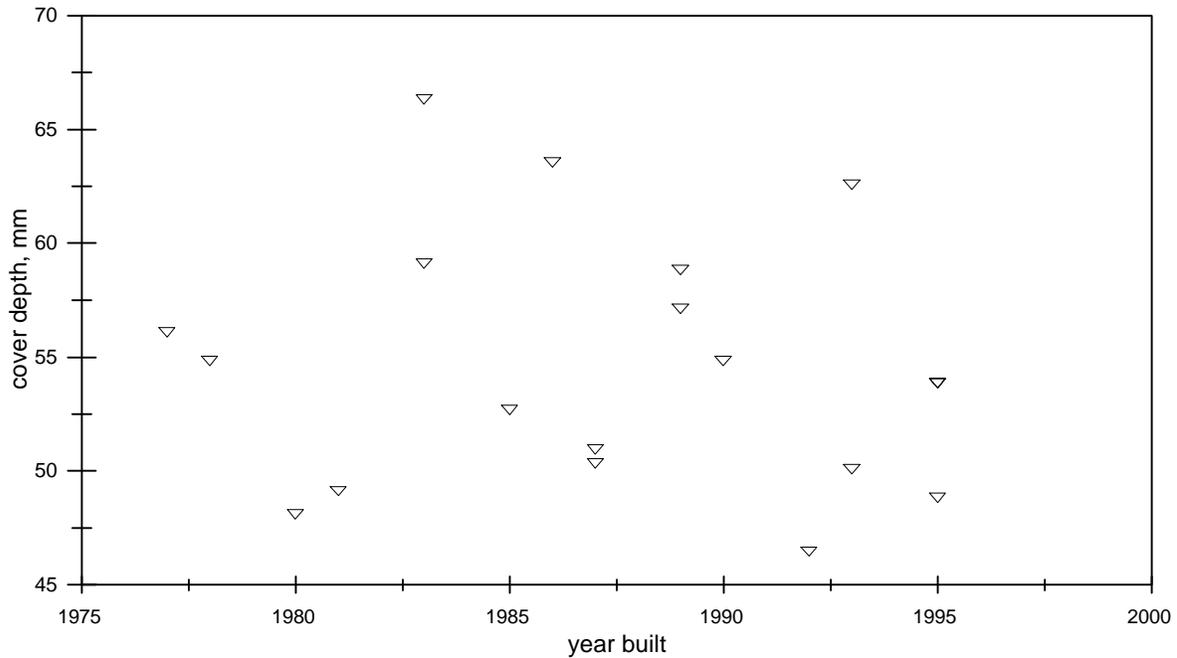
Figure 13.   Span with the Lowest 12[th] Percentile Cover Depth for Each Bridge Deck.

The span on each bridge with the lowest cover depth was identified and the lowest 12 percentile cover depth was determined. Of the 18 decks, 7 decks had the lowest 12 percentile cover depth of less than 50 mm, 8 decks ranged between 51 and 65 mm, and one deck had a lowest 12 percentile cover depth of 66 mm, Figure13.

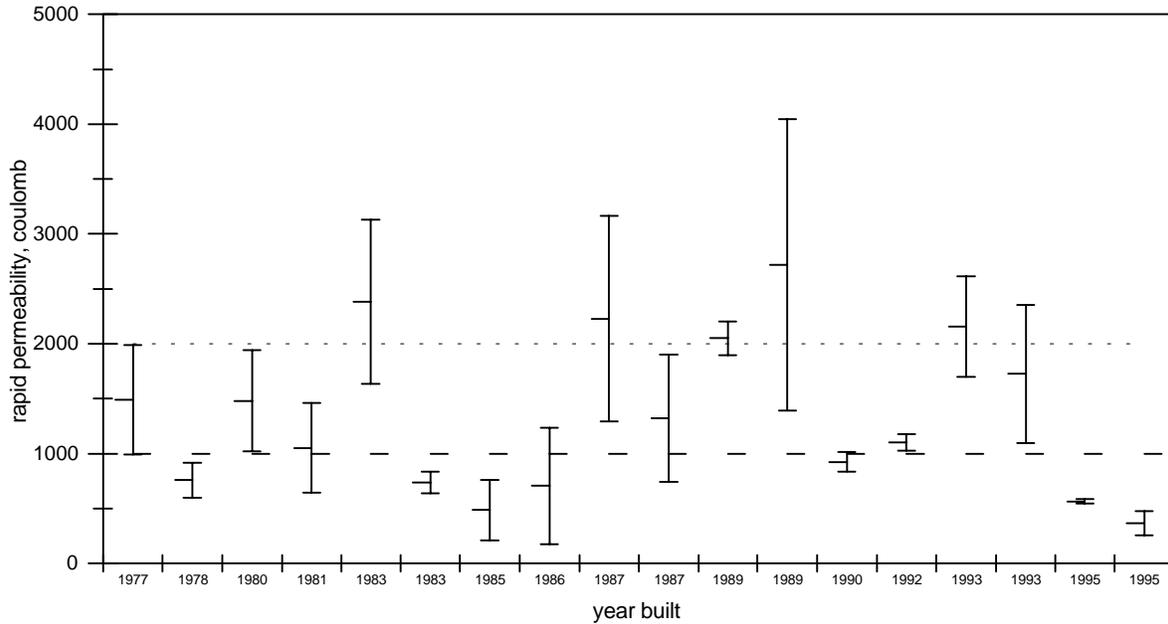
Figure 14.   Rapid Chloride Permeability Test Results, 95% Conf. Interval, Surface Specimens.

For the surface concrete, seven structures had an average charge passed of 1000 coulombs, six structures ranged between 1000 and 2000 coulombs, and the remaining five structures average

surface concrete charge passed was greater than 2000 but less than 3000 coulombs, see Figure 14.

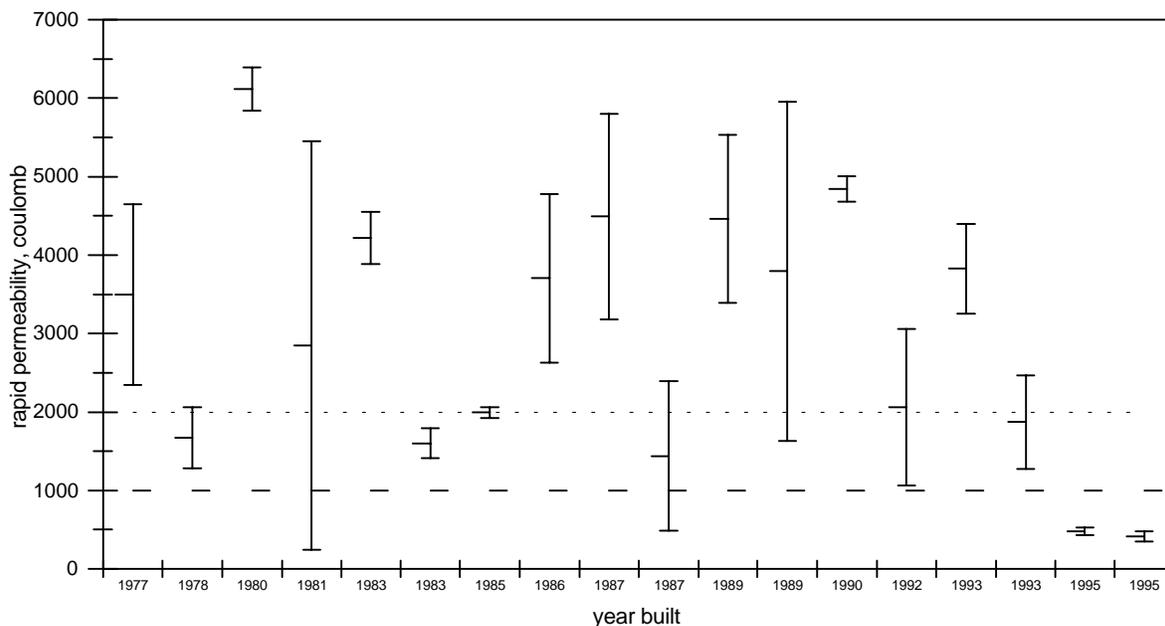
Figure 15.   Rapid Chloride Permeability Test Results, 95% Conf. Interval, Base Specimens.

Two structures had an average base concrete charge passed less than 1000 coulombs, 5 were between 1000 and 2000 coulombs, 2 greater than 2000 but less than 3000, 4 between 3000 and 4000 coulombs, 4 between 4000 and 5000 coulombs and 1 greater than 6000 coulombs, see Figure 15.

Based on the rapid chloride permeability test results, most surface concrete samples indicated very low or low chloride ion penetrability since the measured charge transfer was either below 1000 Coulombs or between 1000 and 2000 Coulombs, respectively. Out of the eighteen tested bridge decks a moderate chloride ion permeability was detected for the following structures only: SN1004 (1993), SN2022 and SN6005 (1989), SN1015 (1987), and SN1004 (1983), Figure 14. These findings vary to some degree from the rapid chloride permeability data obtained for the base concrete samples. Except the very low and low and moderate chloride penetrability, the high chloride ion permeability, above 4000 Coulombs, was detected for the following bridge decks: SN1019 (1990), SN6005 (1989), SN1015 (1987), SN1004 (1983) and SN1032 (1980), Figure 15.

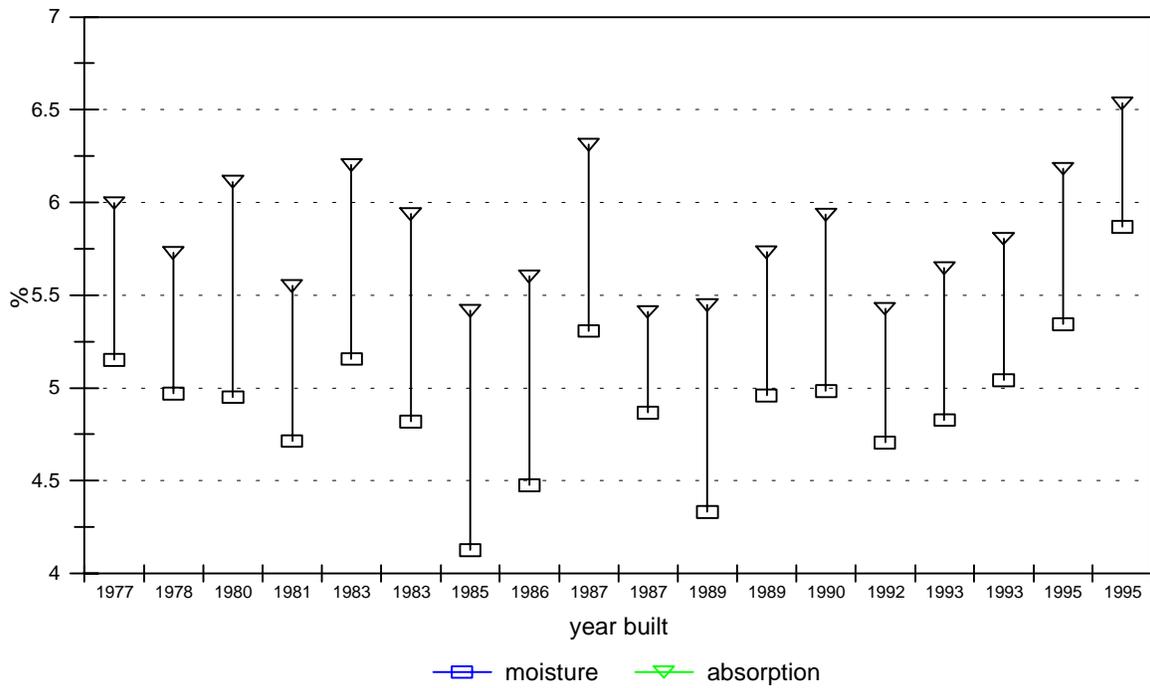
Figure 18. Average Moisture and Absorption, Top Bars.

Figures 16 and 17. Percent average moisture content for the top reinforcement concrete was in the range of 4.0 to 5.5 %, with the exception of one bridge deck , SN1136, built in 1995, which exhibited a moisture content of almost 6.0 %, Figure 18. Percent average absorptions were within the range of 5.4 to 6.5 %.

The moisture content and absorption values of tested concrete bridge decks were relatively uniform for the concrete samples from the top reinforcement level and the truss bar level, between 5.4% and 6.5%, and between 3.5% to 5.5%, respectively, Figures 18 and 19. The determined saturation values for the evaluated bridge decks, in the range of 72% to 92%, agreed with the moisture content and absorption trend, Figure 20. The fairly uniform percent saturation at the top reinforcement verified also findings of the earlier study conducted on bridge decks in Pennsylvania [47].

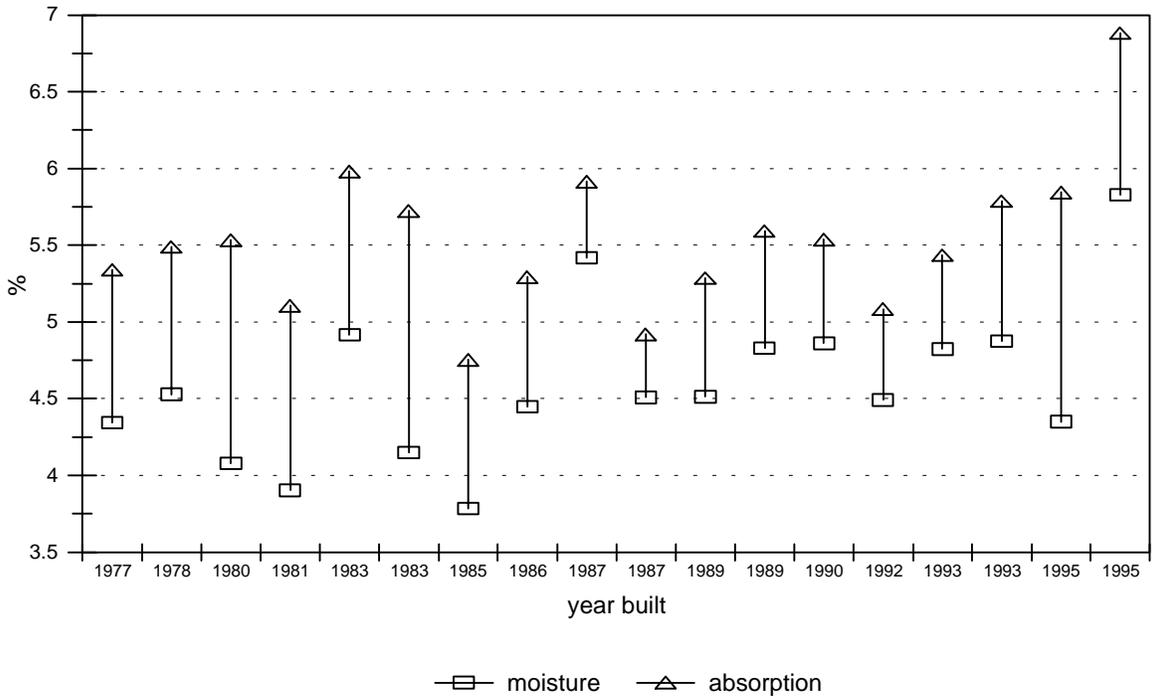
Figure 19. Average Moisture and Absorption, Truss Bars.

Average percent moisture content at the truss bar depth was generally within the range of 3.5 to 5.0 %. However, SN1015 built in 1987 and SN1136 built in 1995, had higher moisture contents of 5.4 and 5.8 %, respectively, Figure 19. The percent average absorption was between 5.0 and 6.0 %, except for one structure, SN1136, which had an average absorption value of 6.9 %. In general, the concrete moisture and absorption contents of top and bottom reinforcing mats agreed with each other, Figures 18 and 19.

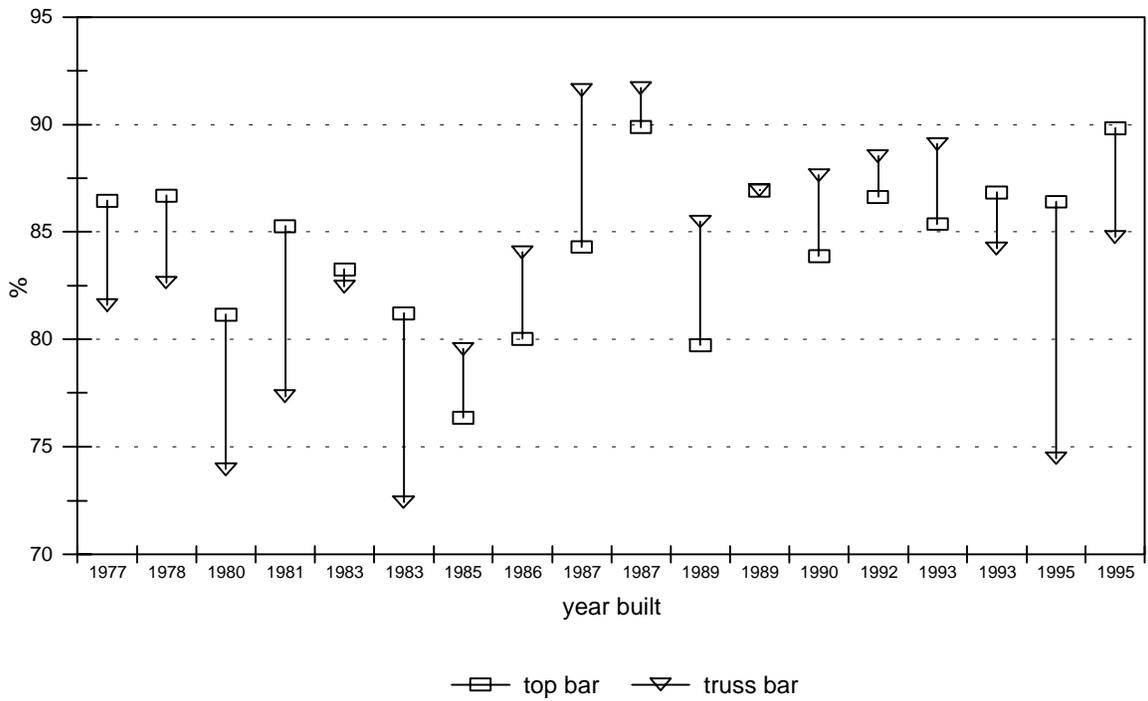
Figure 20. Average Saturation, Top and Truss Bars.

The average saturation for top bars and truss bars was in the range of 72 to 92 %, Figure 20. The higher variability in saturation values was observed for truss bar concrete.

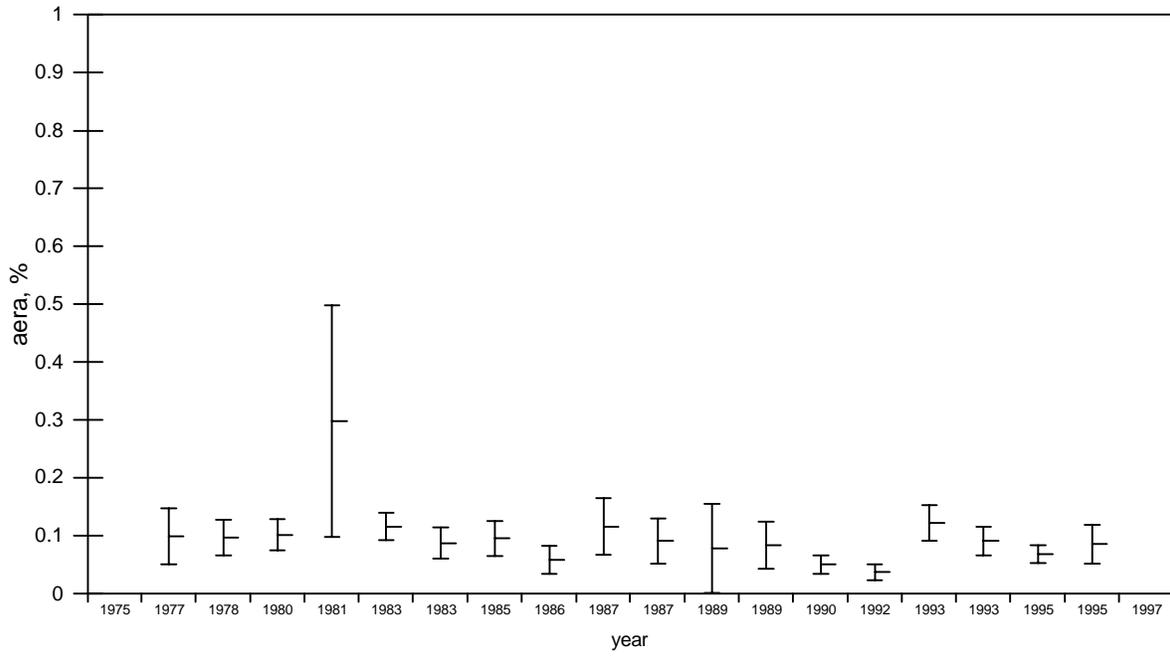
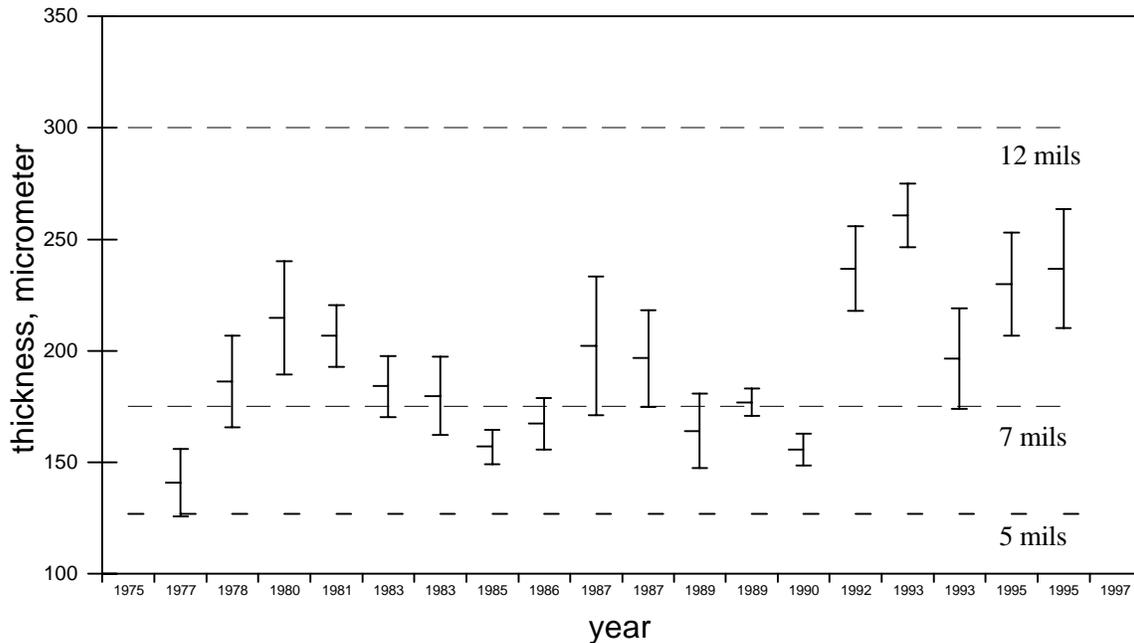
Figure 21.   Average Coating Damage, 90% Confidence Interval, Top Bars.

Damage observed on top and bottom bars was below the specification limit of maximum 1 % in each 0.3 m of the bar, see Figure 21. Average damage for the top bars was between 0.05 and 0.5 %, and within the range of 0 to 0.2 % for the truss bars, Figure 22.

Visual inspection performed on each ECR specimen and coating continuity examination, demonstrated the small percent area damage and low number of holidays. The calculated damage was below 1% of the total surface area in each 0.3 m of the bar for all evaluated bridge decks, top and bottom reinforcing steel, Figures 21 and 22. The measured number of holidays for the top reinforcement met the current specification limit of 3 holidays per meter for all but two inspected bridge decks, Figure 25. One of them, SN1020 (1983) met the previous specification limit, from 1981, of 6 holidays per meter. However, the number of holidays for the other bridge deck, exceeded both specification requirements. In the case of the tested truss bars, based on the obtained number of holidays, ten out of eighteen bridge decks met the current or previous specification limits, Figure 26. The higher variability in the holiday number seems to be related mostly to the smaller sample size of the examined truss bar specimens, two or three from each bridge deck.

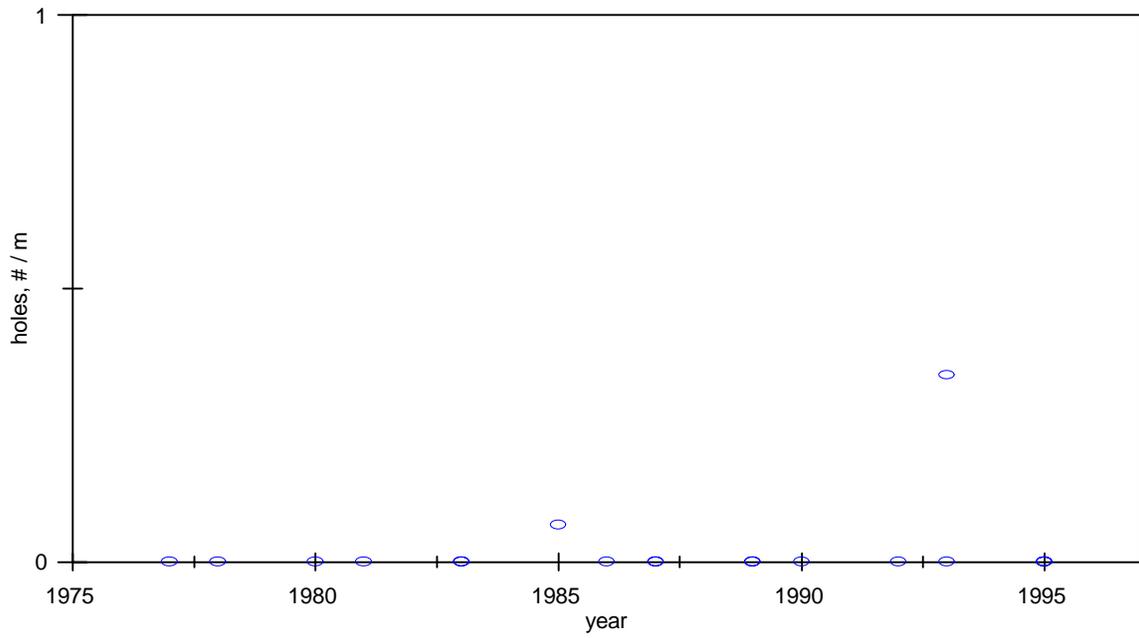
Figure 23.   Average Number of Holes, Top Bars.

Number of holes in the epoxy-coating was determined during the visual inspection of ECR specimens. For the ECR specimens from the top mat, the average number of holes was equal to 0, with the exception of two bridge decks, SN2262 built in 1985 and SN1006 built in 1993, where the average number of holes was 0.07 and 0.34 holes per meter, respectively, Figure 23. For the truss bars, holes were detected only in one set of specimens, SN2068, built in 1978. The average number of holes was 1.09 holes per meter, see Figure 24.

The number of holes was used as an additional characteristic assigned to evaluate the epoxy-coating. The obtained average number of holes was smaller than 1 for all tested top bars and for the most of the inspected truss bars, with the exception of one bridge deck, SN2068 (1978), Figures 23 and 24.   ASTM specification does not include holes as a separate type of coating

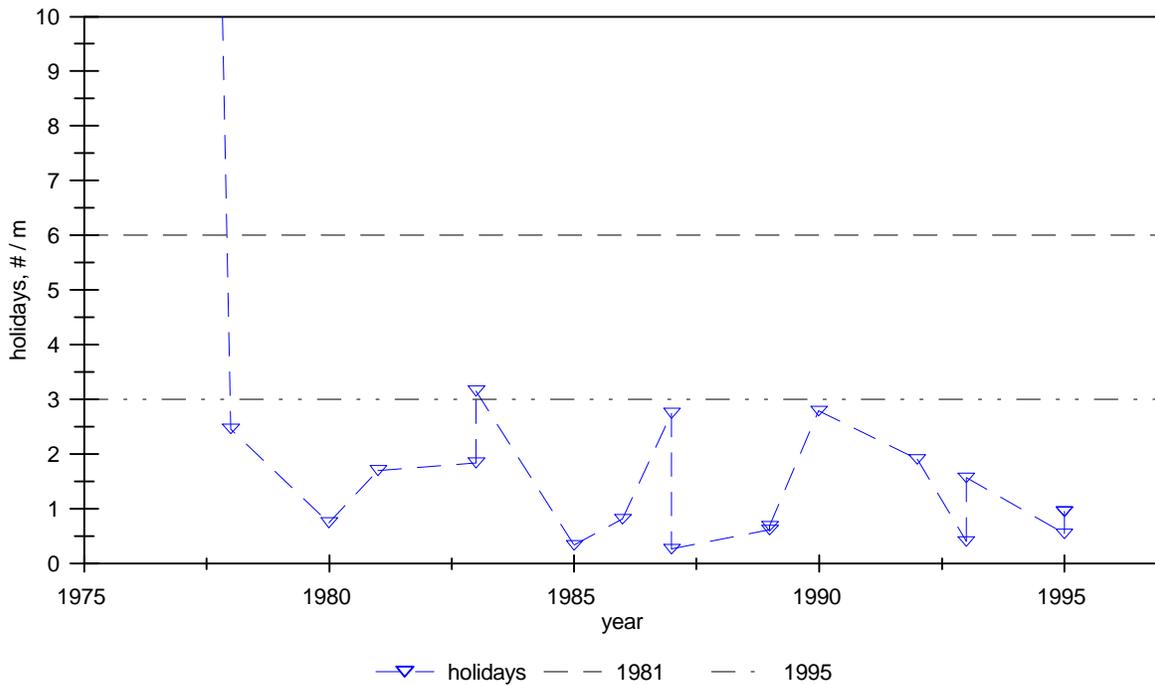
Figure 25. Average Number of Holidays, Top Bars.

Number of holidays per meter was examined on each ECR specimen. Average number of holidays was also determined for every bridge deck, Figures 25 and 26. Top bar inspection showed one bridge deck built in 1977, SN1056, that had an average of 44 holidays per meter in the epoxy-coating, and one structure, SN1020 built in 1983, with an average holiday number per meter equal to 3, Figure 25. Both values are above the specification limit from 1995, which recommends 3 holidays per meter. However, the specimens from SN1020 built in 1983 met the specification limit of 6 holidays per meter, dated 1981, in use at the time of construction. Average number of holidays per meter for the other bridge decks was in the range of 0 to 3, Figure 25.

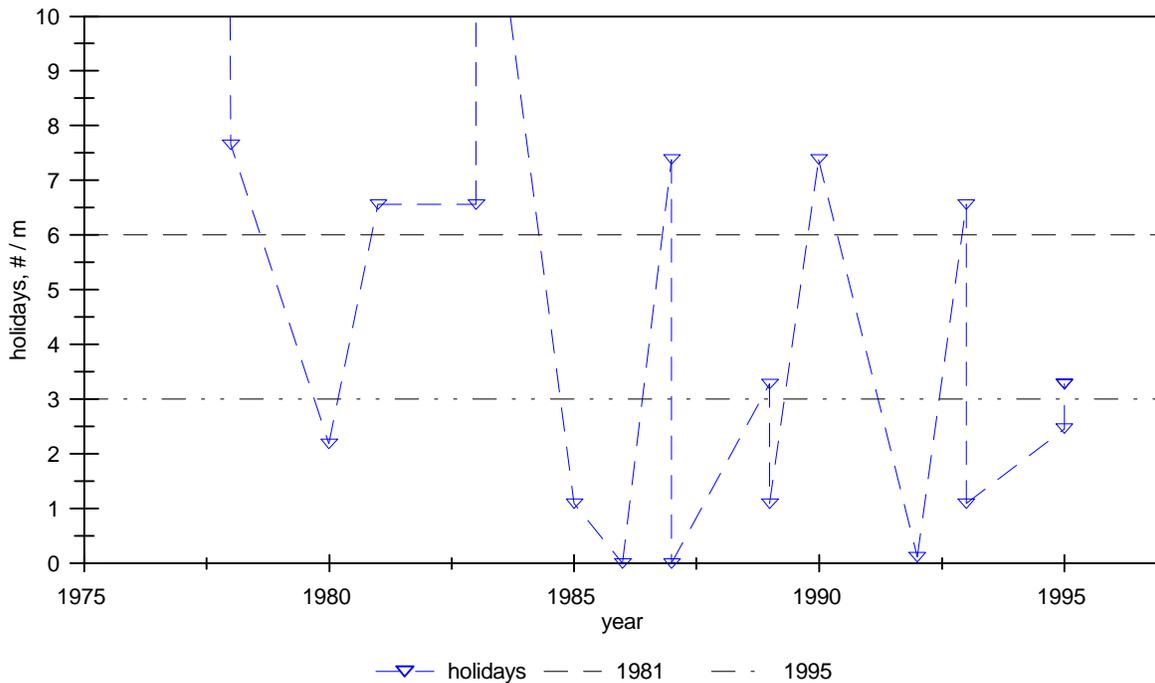
Figure 26.   Average Number of Holidays, Truss Bars.

ECR specimens from truss bars have higher variability in number of holidays per meter which is probably related to the small sample size, 2 or 3 specimens from each bridge deck., Figure 26. Three structures had number of holidays equal or close to zero, SN1029 built in 1986, SN1987 built in 1987, and SN1001 built in 1992. Five structures met the current specification limit of 3 holidays per meter, SN1032 from 1980, SN2262 from 1985, SN2022 from 1989, SN1006 from 1993, and SN6243 built in 1995. Two sets of specimens from SN6005 and SN1136, built in 1989 and 1995, respectively, were slightly above the new specification limit, 3 holidays per meter, but met the older specification limit, 6 holidays per meter. Average number of holidays for specimens extracted from the other eight structures exceeded both specification limits. Especially bridge decks, SN1056 built in 1977 and SN1020 built in 1983 had the highest average number of holidays of 246 and 15 per meter of bar, respectively, Figure 26.

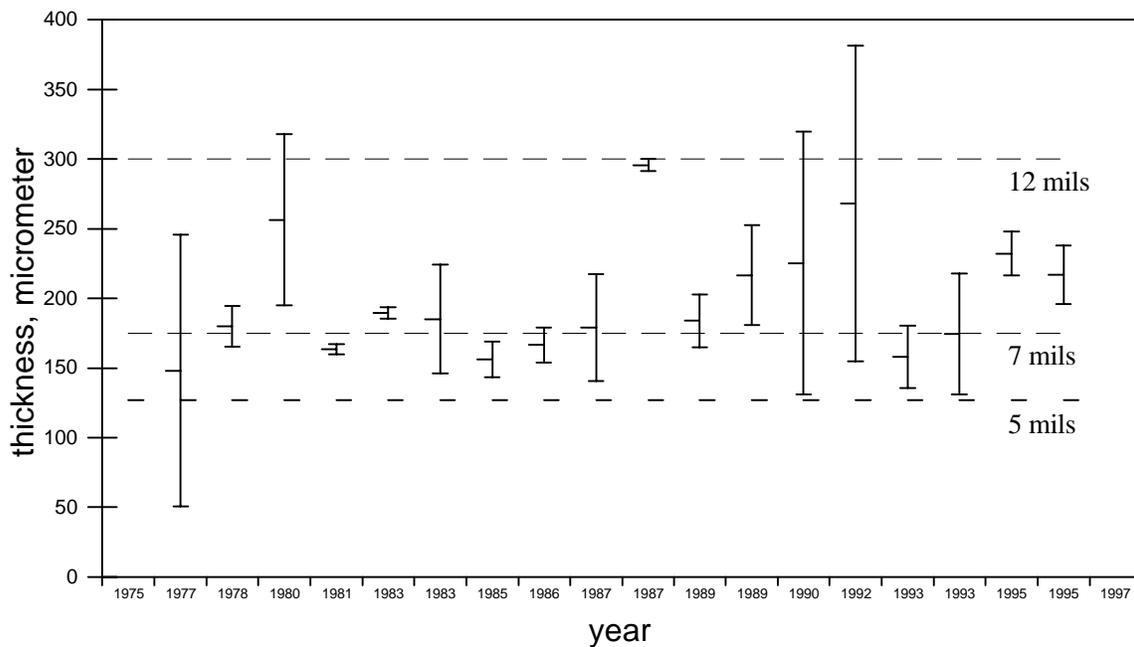
Figure 28.   Average Coating Thickness, 90% Confidence Interval, Truss Bars.

The average of all readings on top bar specimens from 13 of the 18 decks were within the specification range of 175 to 300 μm. The other five bridge decks, SN1056 built in 1977, SN2262 built in 1985, SN1029 built in 1986, SN6005 built in 1989, and SN1019 built in 1990, which had average coating thicknesses between 125 and 175 μm, Figure 27. Within the group of truss bar specimens, five bridges, SN1056 built in 1977, SN2021 built in 1981, SN2262 built in 1985, SN1029 built in 1986, and SN1006 built in 1993, average coating thickness was below the lower specification limit of 175 μm, but greater than 125 μm, Figure 28.

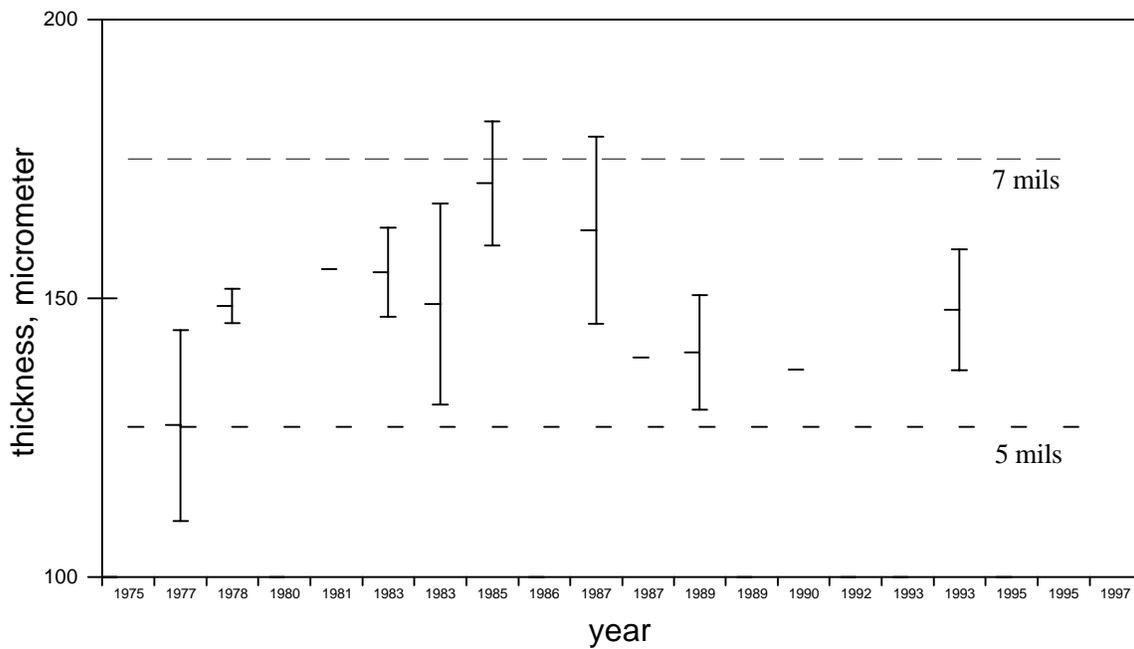
Figure 29.   Average Coating Thickness, Rejected Top Bars, 90% Conf. Interval.

A coating thickness of 125 μm is the lowest thickness allowed for ECR according to ASTM A 775 - 95. If a single recorded measurements is below the value of 125 μm, the bar is rejected. Using this approach, during the testing procedure, some ECR specimens were discarded from further evaluation because of their low thicknesses. Average coating thicknesses of the rejected top bar and truss bar specimens are presented in Figures 29 and 30. Percent ECR specimens that were discarded from the experiment based on the measured coating thickness are shown in Figures 31 and 32. Number of rejected bars varied among evaluated bridge decks between 0 and 70 % for top and truss bars. No general trend regarding the low coating thickness was observed for top bars and truss bars, respectively. New average coating thicknesses were determined after excluding rejected bars, Figures 33 and 34. However, the general tendency for the average coating thickness stayed unchanged.

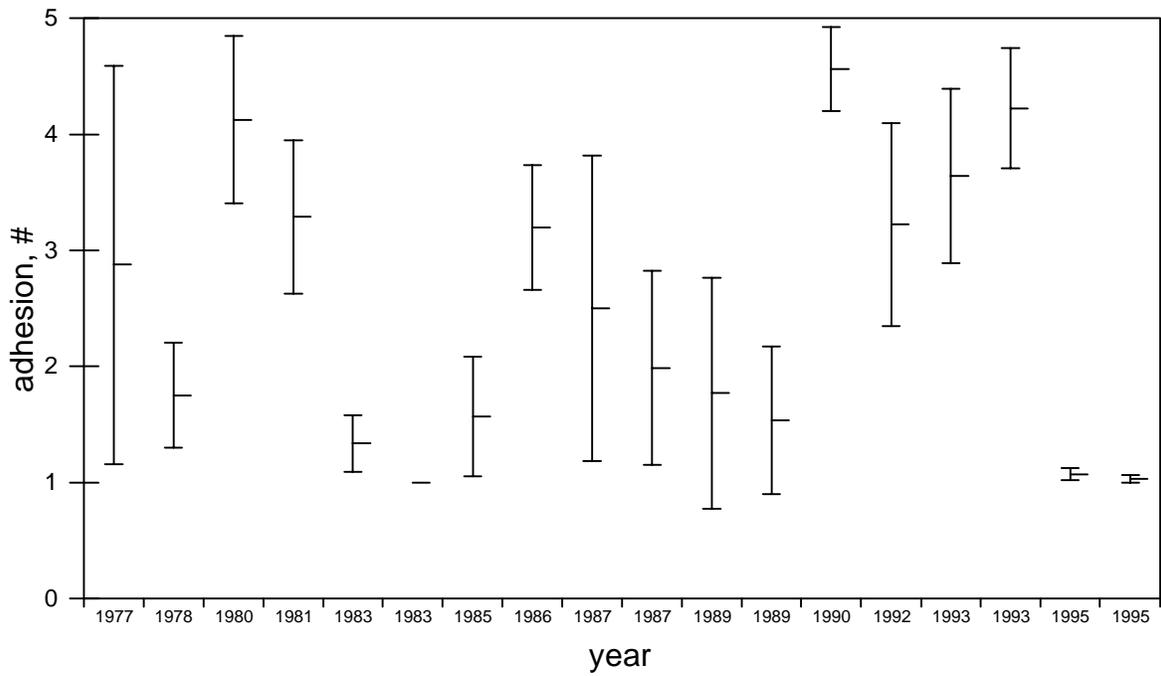
Figure 35.　　　Average Coating Adhesion, Thickness Accepted Top Bars, 90% C.I..

Adhesion of epoxy-coating to reinforcing steel was determined using the knife-peel test described in the Method & Material section. ECR specimens rejected because of their low coating thickness were discarded from adhesion testing. Only three of tested bridge decks had an average adhesion value equal to 1, SN1020 built in 1983, SN6243 and SN1136 built in 1995, Figure 35. Average adhesion values equal or greater than 3 were observed for the following bridge decks: SN1032 built in 1980, SN2021 built in 1981, SN1029 built in 1986, SN1019 built in 1990, SN1001 built in 1992, and SN1004 and SN1006 built in 1993. In the case of truss bars, average adhesion values were above 3 for all bridge decks except, SN1004 and SN1020 built in 1983, SN6161 built in 1987, SN1006 built in 1993, and SN6243 and SN1136 built in 1995, Figure 36. Percent of average adhesion values equal or greater than 3 was also determined, Figures 37 and 38. For top mat ECR specimens, the percent of average adhesion values equal or greater than 3 was between 10 and 90, except structures, SN1004 and SN1020 built in 1983, SN2262 built in 1985, and SN6243 and SN1136 built in 1995, Figure 37. Similar observations were made for the truss bars, with the percent of average adhesion equal or higher than 3, ranging between 30 and 100, with an exception of SN1004 and SN1020 built in 1983, SN6161 built in 1987, SN1006 built in 1993, and SN6243 and SN1136 built in 1995, Figure 38.

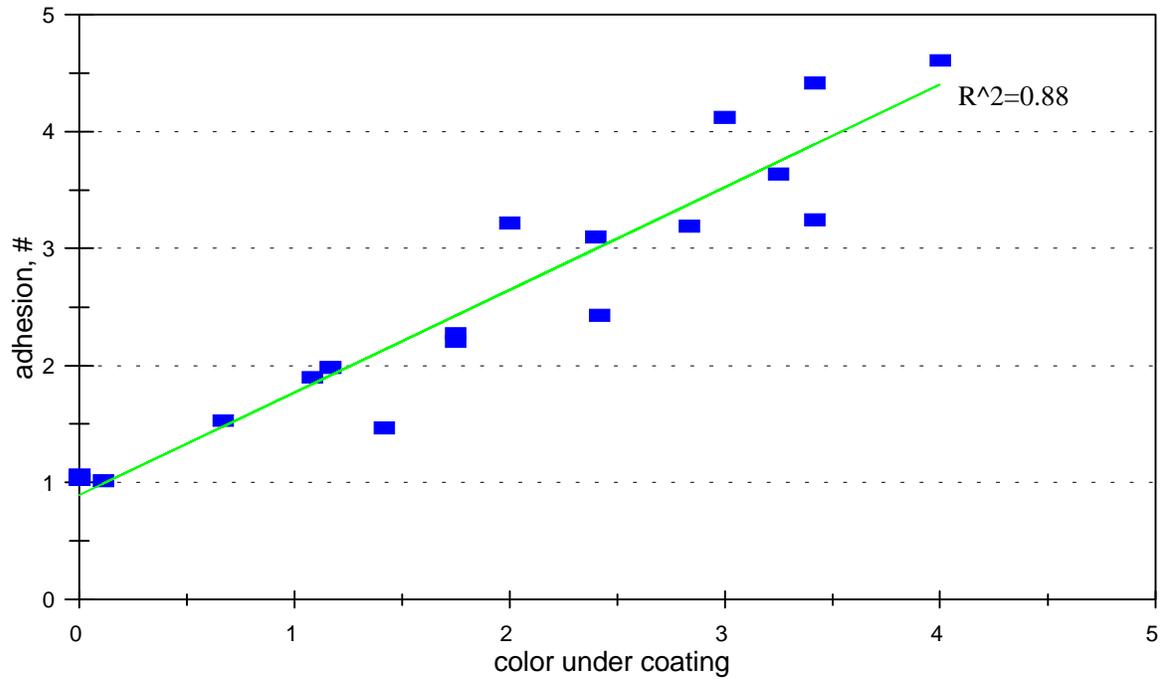
Figure 39.   Average Adhesion and Steel Color Relation, Top Bars.

The visually observed color of the steel under the peeled epoxy-coating was noted and numerical values were assigned to the observed colors, see Table 8. A correlation was established between the color of the steel surface under the coating and the adhesion values, Figures 39 and 40. The linear relationship had R^2 values of 0.88 for the top bars and 0.7 for the truss bars.

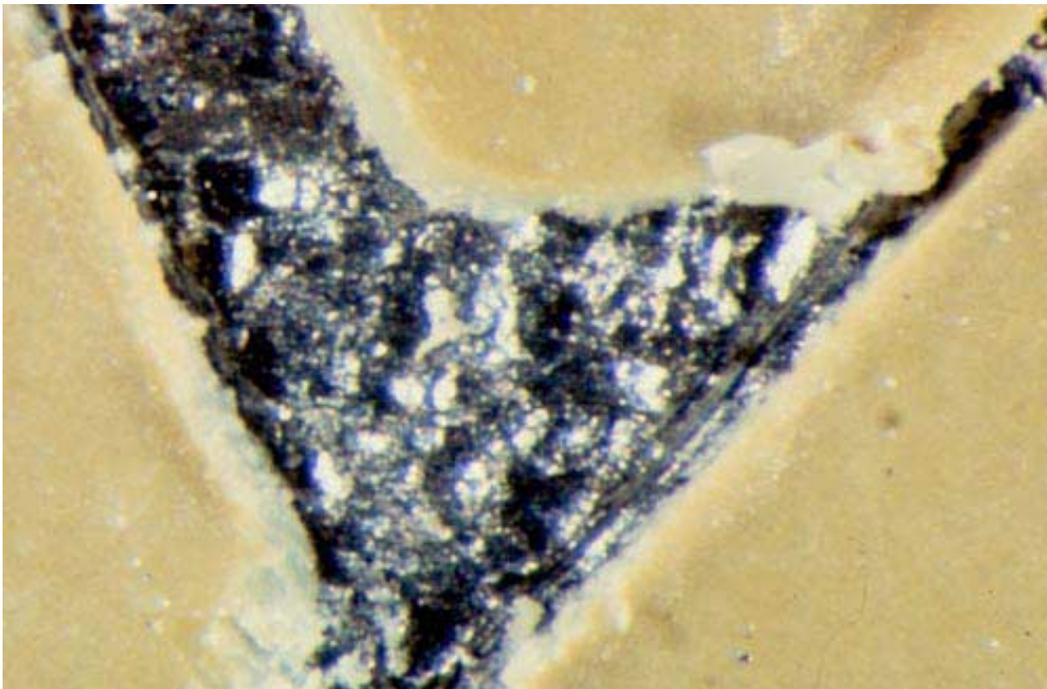
Figure 41.   Shining Steel Surface Underneath Coating.

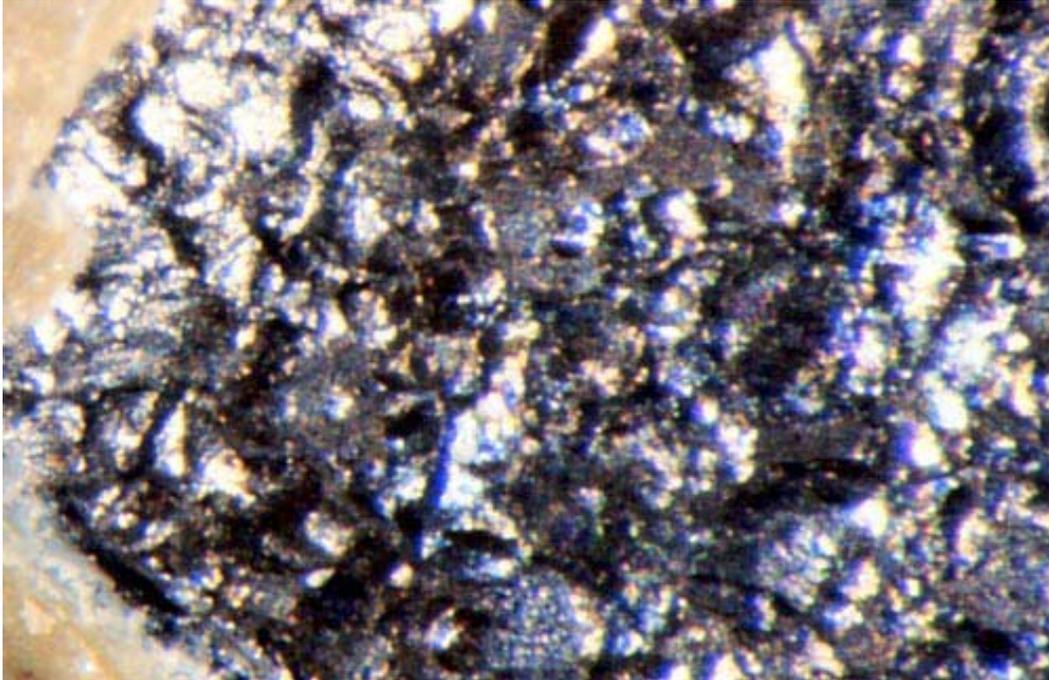
Figure 42.   Gray, Shining Steel Surface Underneath Coating.

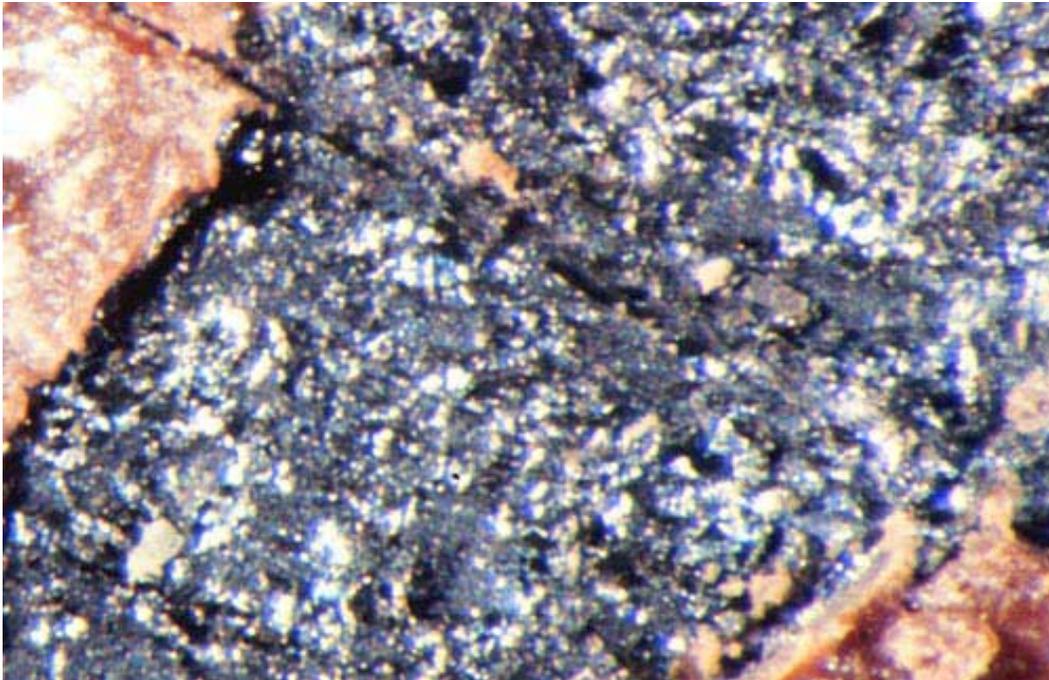
Figure 43.   Dark Gray, Shining Steel Surface Underneath Coating.

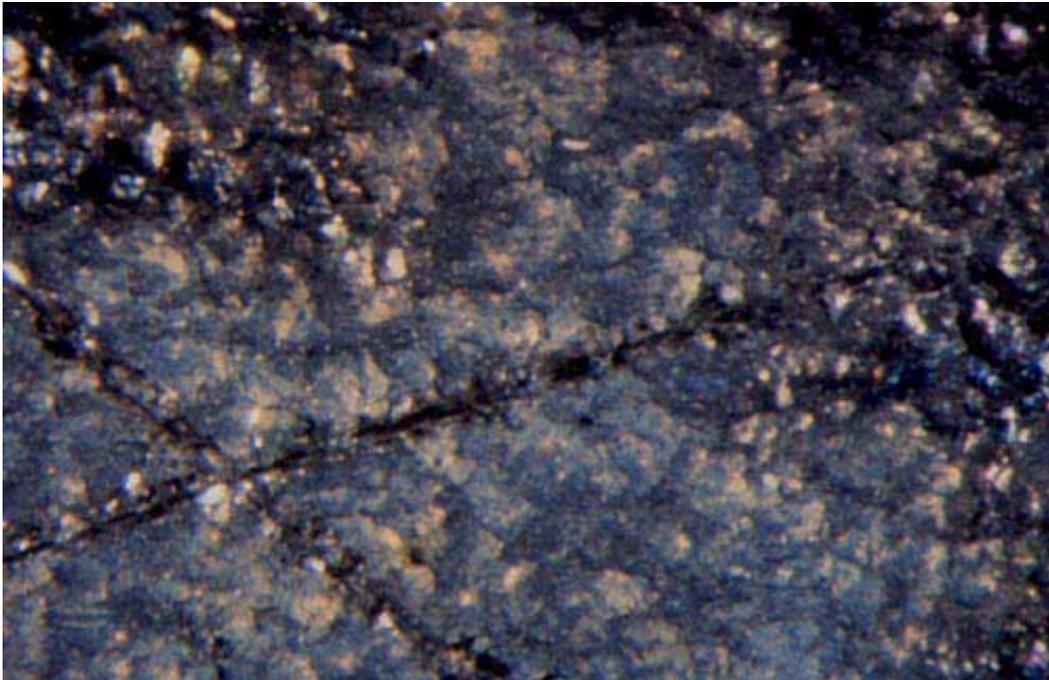
Figure 45.   Black Steel Surface Underneath Coating.

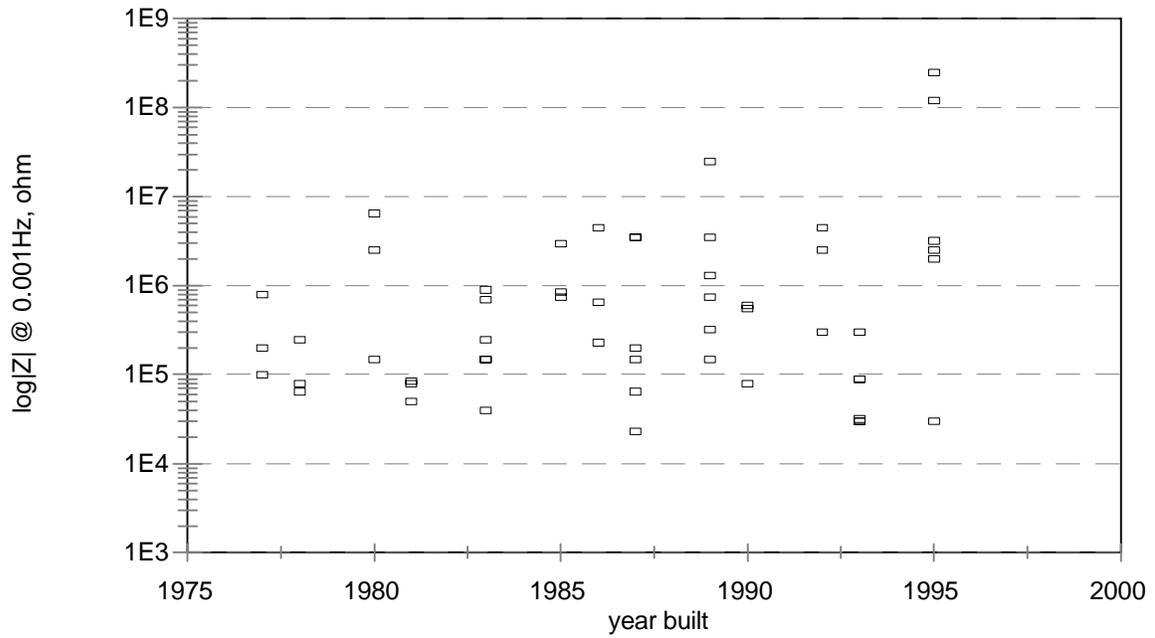
Figure 46. Impedance Data for 18 Bridge Decks.

excellent corrosion resistance, overall impedance values greater than 10^8 ohm/cm^2, coatings with an intermediate effectiveness, impedance values between 10^6 and 10^8 ohm/cm^2, and coatings with a poor corrosion resistance, impedance values below 10^6 ohm/cm^2 [29]. Other researchers indicated that impedance measurements greater than 10^5 ohm are typical for an intermediate coating quality, and impedance values lower than 10^5 ohm represent poor quality coatings [A]. It should be mentioned that these correlations were made for a low frequency measurements, for example 0.001 Hz. Impedance values at the frequency of 0.001 Hz obtained in this study were in the range of 10^4 ohm and 10^7 ohm for sixteen out of the eighteen evaluated bridge decks. The only two bridge decks that have experienced higher impedance readings, slightly above 10^8 ohm, were SN6243 and SN1136 constructed in 1995, Figure 46.

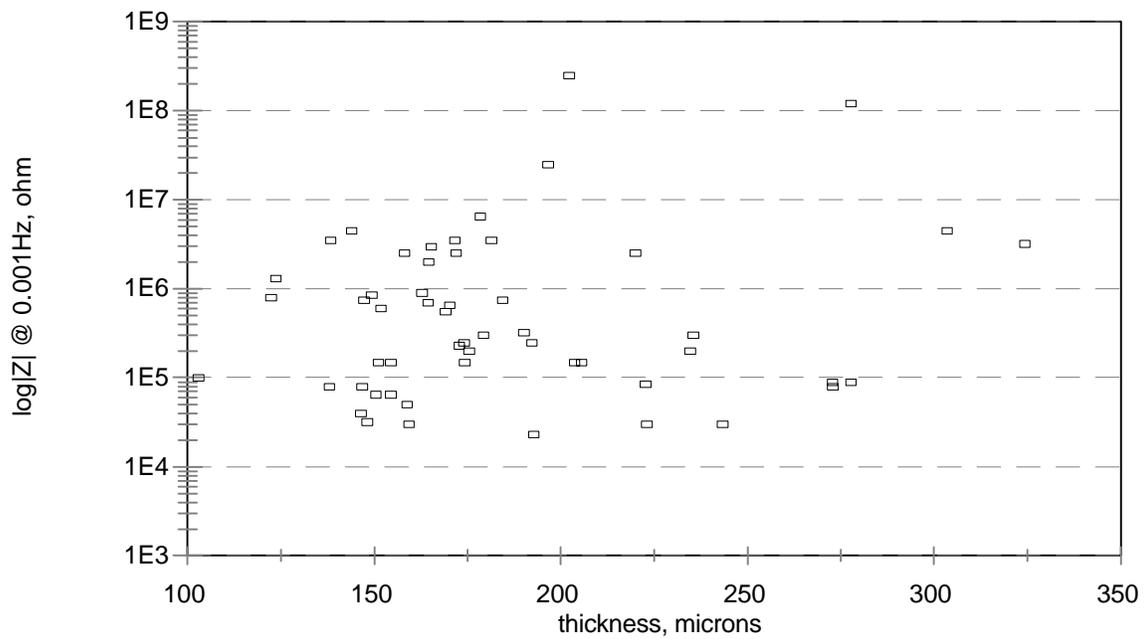
Figure 47. Impedance at Low Frequency, 0.001Hz, vs. Coating Thickness.

Impedance values determined at 0.001 Hz were plotted against various ECR properties: coating thickness, percent area damage, holiday number, coating adhesion, and color of steel underneath the coating. No correlation was found between the impedance, Z, and coating thickness. An increase in coating thickness was not followed by a higher impedance value. For the thickness equal to 200 μm the highest and the lowest impedance values were observed, 10^8 ohm and 10^4 ohm, respectively, Figure 47.

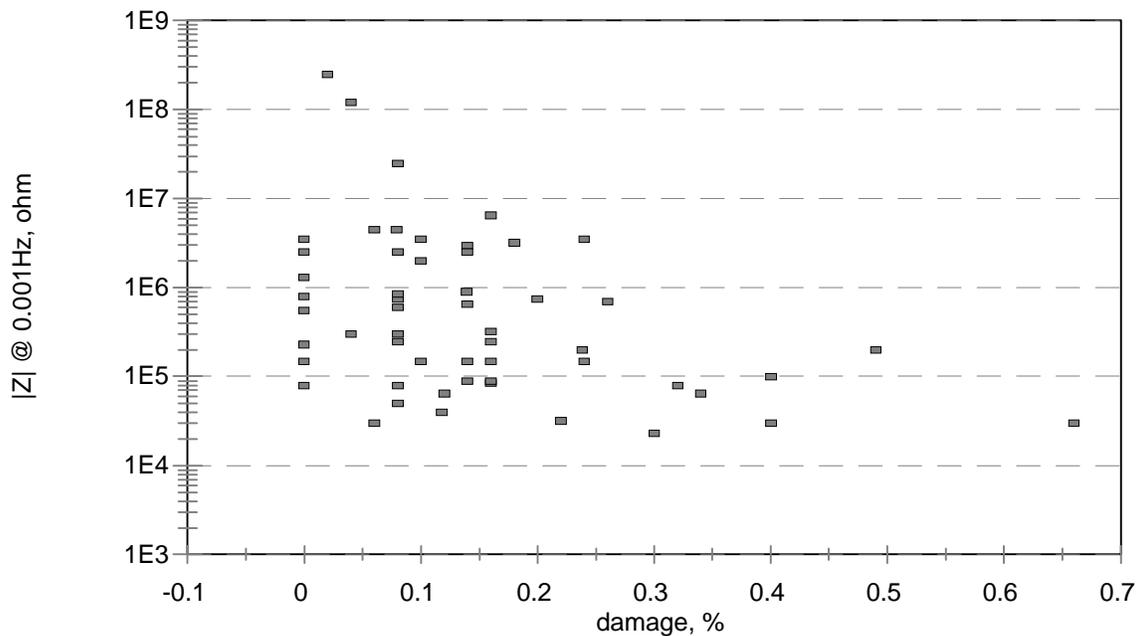
Figure 48. Impedance at Low Frequency, 0.001Hz, vs. Percent Area Coating Damage.

Better correlation was detected for the low frequency impedance and the percent area damaged of ECR specimens. Although the data seemed to be scattered they give an overall impression of the decreasing impedance, Z, with an increased damage in the coating. The highest impedance, 10^8 ohm, was observed for the specimens with almost a non visible damage and the lowest, 10^4 ohm, was determined for a 0.65 % area damage, Figure 48 Similar correspondence was detected for the measured coating impedance and number of holidays in the coating. The highest impedance values were typical for ECR specimens with no holidays and had gradually decreased with a growing holiday number, Figure 49.

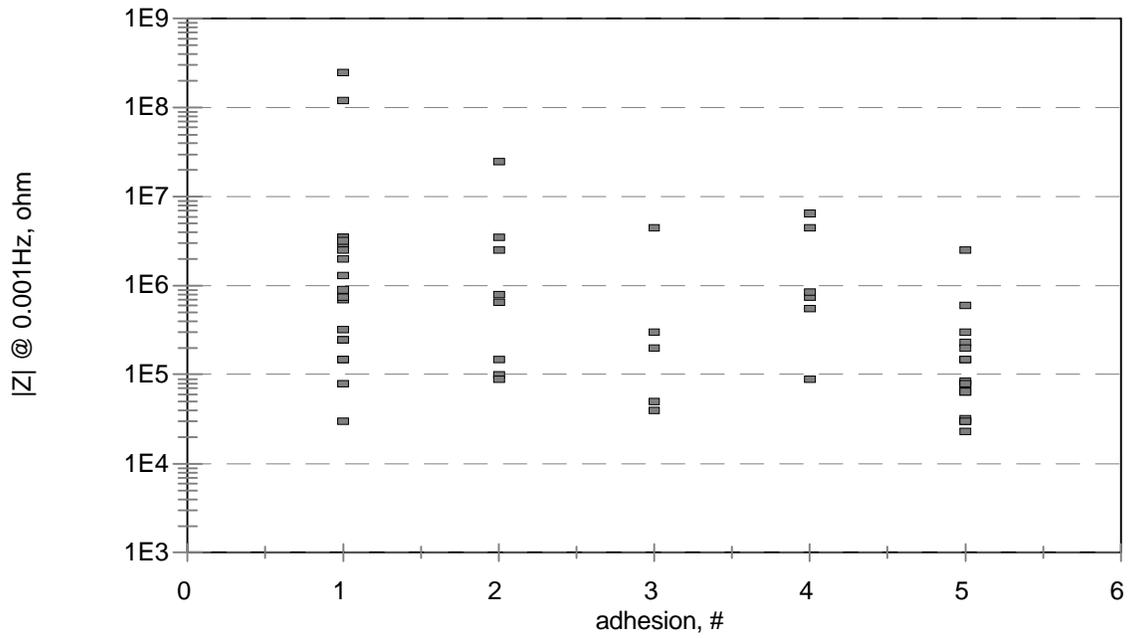
Figure 50. Impedance at Low Frequency, 0.001Hz, vs. Coating Adhesion.

A comparison between the low frequency impedance and coating adhesion demonstrated lower frequency values for higher adhesion numbers, which represent the loss of adhesion of the coating to the steel surface. The maximum impedance of 10^8 ohm was measured for the adhesion value of 1 and the lowest impedance, 10^4 ohm, for the adhesion equal to 5, Figure 50. A similar trend was observed for the low frequency impedance and a color of a steel surface under the coating where the higher impedance values represented a more shining steel surface and lower impedance measurements were characteristic of steel surface covered with an oxide layer, Figure 51.
