FIELD PERFORMANCE OF EPOXY-COATED REINFORCING STEEL
IN VIRGINIA BRIDGE DECKS

Dissertation submitted to the Faculty of the
Virginia Polytechnic Institute and State University
in partial fulfillment of the requirements for the degree of

Civil Engineering

September 4, 1998

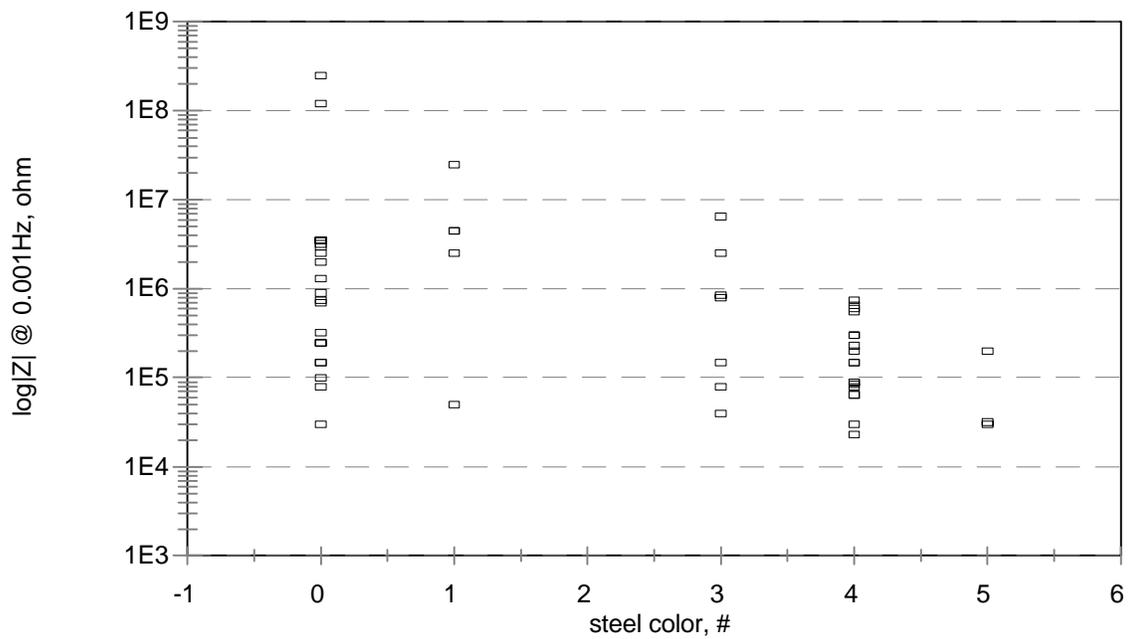
Figure 51. Impedance at Low Frequency, 0.001 Hz, vs. Color of Steel Underneath Coating.

A comparison between the low frequency impedance and coating adhesion demonstrated lower frequency values for higher adhesion numbers, which represent the loss of adhesion of the coating to the steel surface. The maximum impedance of 10^8 ohm was measured for the adhesion value of 1 and the lowest impedance, 10^4 ohm, for the adhesion equal to 5, Figure 50. A similar trend was observed for the low frequency impedance and a color of a steel surface under the coating where the higher impedance values represented a more shining steel surface and lower impedance measurements were characteristic of steel surface covered with an oxide layer, Figure 51.

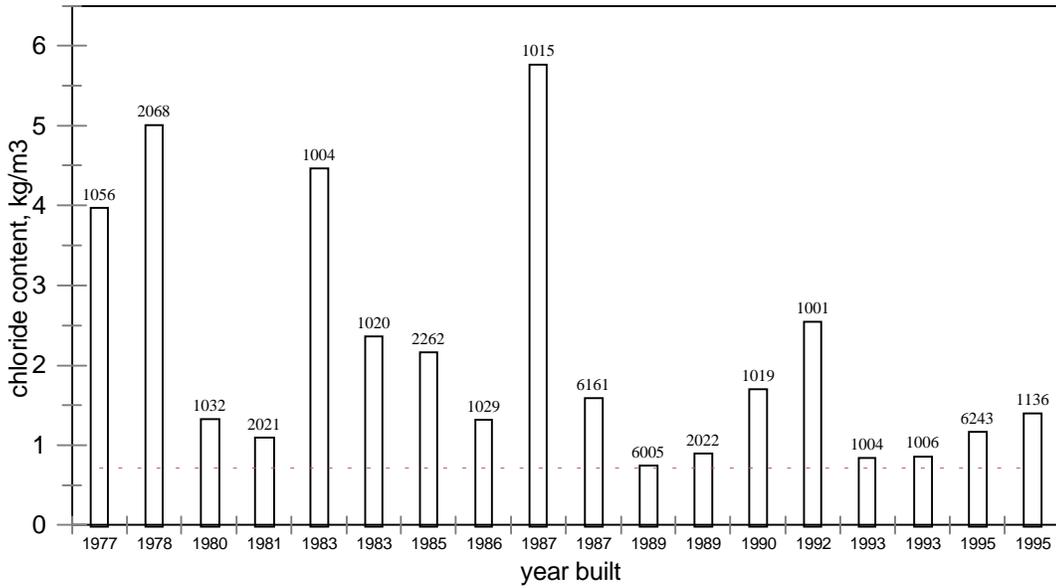
Figure 55. Average Chloride Content at 13 mm Depth.

Average chloride content in concrete at the depth of 13 mm was determined for each bridge deck, Figure 55. Based on the obtained chloride content values at 13 mm a chloride concentration at the reinforcing steel depth was calculated using the following equation [70], Figure 56. An equation found using the lowest significant level, standard deviation, and results from a linear regression

where y is the chloride content (lbs/yd^3) at the bar level and x is the chloride content (lbs/yd^3) at 13 mm depth. The computed chloride concentrations at the reinforcing steel depth were below the chloride corrosion threshold limit in concrete for all bridge decks except four: SN1015 (1987), SN1004 (1983), SN2068 (1978), and SN1056 (1977), Figure 55.

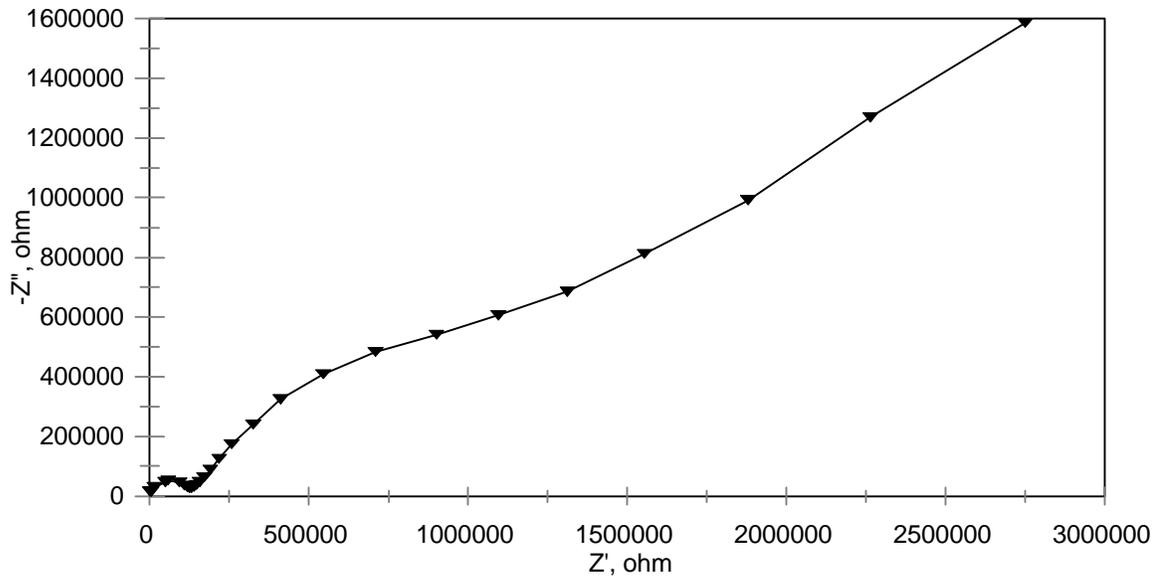
Figure 57A. Type N1 Nyquist Plot, SN2262, Core #3.

Three main curve shapes determined for tested ECR specimens represent a slightly different behavior, Figures 57A, 58A and 59A. The small semicircle at high frequency for the ECR specimen core #3, SN2262, in Figure 57A, indicated a formation of conductive pathways in the coating and the low coating pore resistance, demonstrated by the small diameter of the circle. The larger incomplete semicircle formed at lower frequencies symbolized the charge transfer reaction. The second semicircle was followed than by the diffusion tail, representing the diffusion controlled corrosion process taking place at the metal substrate, Figure 57A. The phase angle shift at the low frequency, present in the phase angle diagram, was attributed to the diffusion process, Figure 57B.

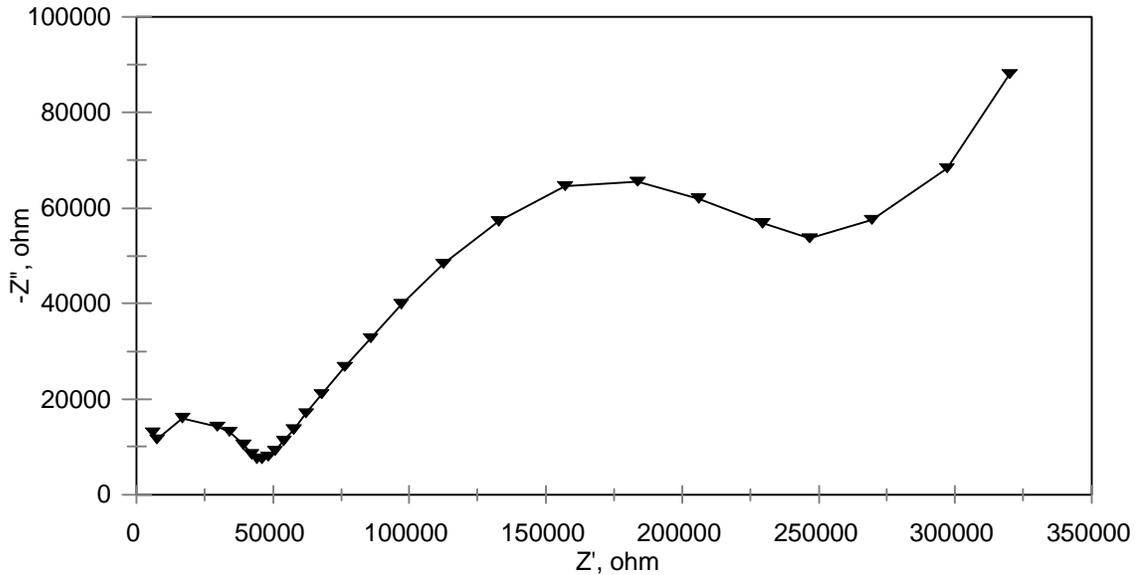
Figure 58A. Type N2 Nyquist Plot, SN2022, Core #8.

The second type of the Nyquist diagram, N2, observed during the EIS testing procedure, demonstrates a permeable coating with a higher coating resistance which could be seen from the larger diameter of the high frequency semicircle, Figure 58A. The low frequency semicircle, clearly visible this time, and a small diffusion tail for the tested core #8, SN2022, ECR specimen, revealed the corrosion process at the metal surface attributed mainly to the charge transfer reaction. Again the phase angle shift at the low frequency was related to the diffusion process, Figure 58B.

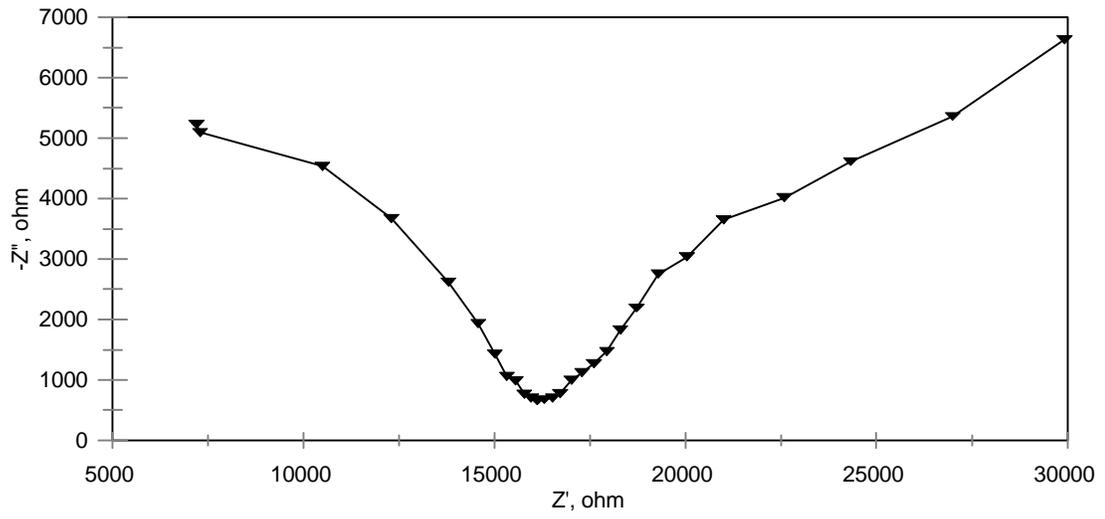
Figure 59A. Type N3 Nyquist Plot, SN1006, Core #6.

Figure 59A demonstrates a completely different behavior. The high frequency semicircle has not formed at this time suggesting a full permeability of the coating. An incomplete charge transfer circle and a diffusion tail represented a corrosion process taking place at the metal surface and being controlled by these two phenomenon. This statement can be supported by the constant phase angle observed from the phase angle plot, Figure 59B.

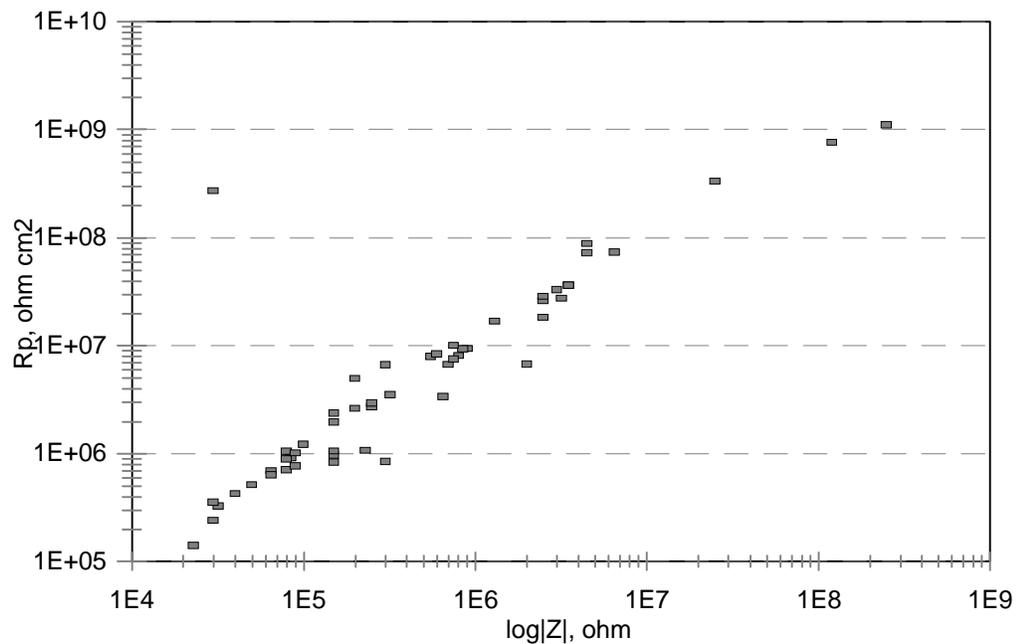
Figure 60. Polarization Resistance, R_p, vs. Impedance, $|Z|$, at 0.001Hz.

The comparison of the polarization resistance data and the impedance values measured at the low frequency of 0.001 Hz for 54 ECR specimens embedded in concrete cores, 3 from each bridge deck, gave an indication of a linear relation between these two properties, Figure 60. The only exception was one value with the polarization resistance being relatively higher than the impedance, 10^8 ohm cm^2 and 10^4 ohm, respectively. In general, the findings demonstrate that polarization resistance of ECR is an equivalent of the sum of coating pore resistance, charge transfer resistance, and the diffusion impedance.

Corrosion rates obtained from the polarization resistance measurements may not be the correct values, since the technique works properly with systems where the only significant anodic reaction is metal oxidation [69]. The corrosion mechanism that generates on the steel surface underneath the epoxy coating seems to be more complicated than a typical metal oxidation process.
