Hot Dip Galvanized Case Study No. 4 (Revision)

Hot Dip Galvanized Reinforcement in Concrete

This case study is the result of a detailed investigation of a pedestrian bridge situated along the foreshore of Algoa bay.

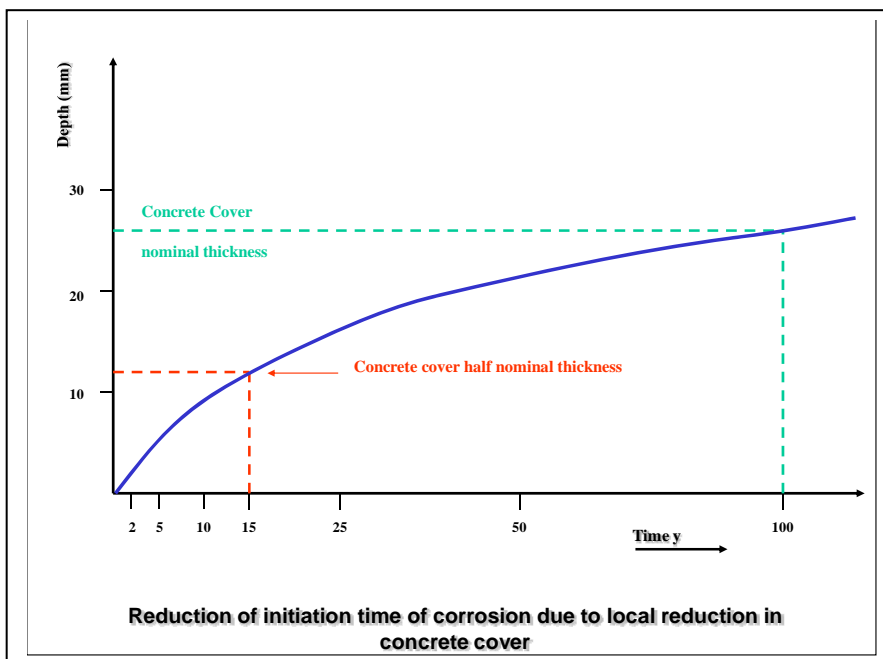
This diagram illustrates the importance of concrete cover. The concrete cover represents a form of “barrier protection” through which the corrosive elements must pass before attack on the reinforcement can commence.
