CORROSION OF THE ZINC ALLOY COATING IN GALVANIZED REINFORCED CONCRETE

S.R. Yeomans
University College
University of New South Wales
Australian Defence Force Academy
Canberra ACT 2600 AUSTRALIA

ABSTRACT

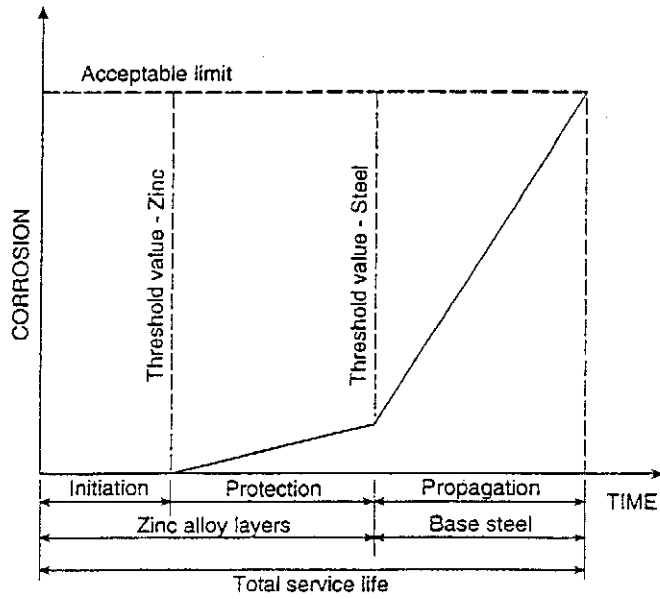
Figure 1. Service life model for galvanized steel in concrete

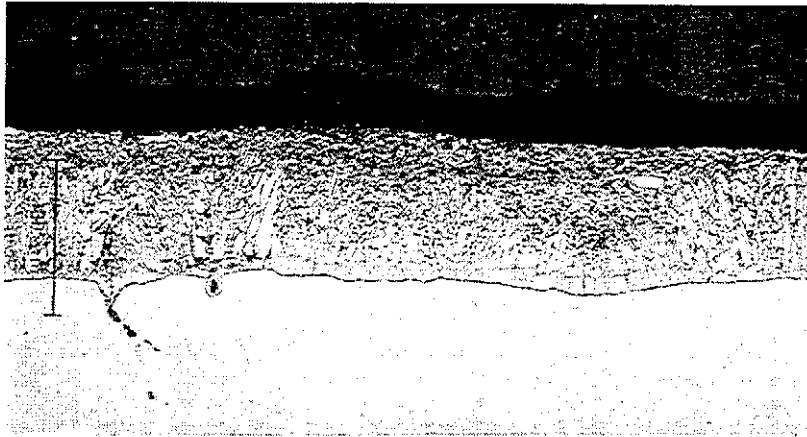
Figure 2. Microstructure of hot dip galvanized layer (200x)

The original microstructure of the galvanized layer is shown in Figure 2. This reveals the typical alloy layer structure of the coating with the pure zinc *eta* layer at the outside, and the *zeta* (5-6% Fe) and *delta* (7-12% Fe) phases progressively below. The thin iron-rich *gamma* phase (21-28% Fe) at the interface with the underlying steel is not visible at this magnification. The average coating thickness of this sample is of the order of 90-95 μ .

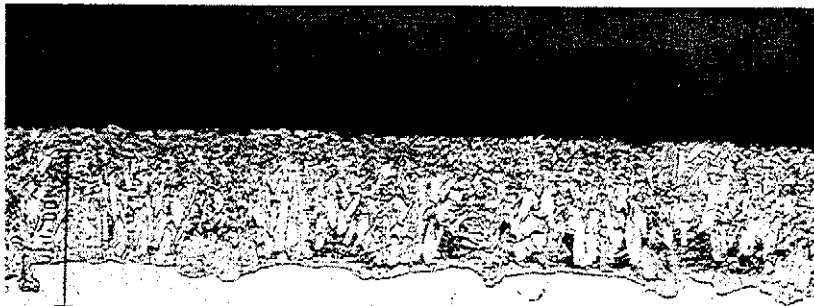
Figure 3. Microstructure of hot dip galvanized layer after short term exposure to cement (200x)

The examination revealed that once the galvanized steel comes in contact with cement mortar, there is an immediate loss of an amount of zinc, primarily the pure zinc *eta* layer, from the coating surface. This feature of the corrosion of zinc in concrete, namely the consumption of a small quantity (perhaps as much as 10 μ thickness) of pure zinc at the coating surface for the passivation process, is well documented.^{6,7} At this stage, the coating is, on the whole, only slightly reduced in thickness though there is preliminary evidence of tunnelling through the coating beneath the outer layers of the coating where intrusions of pure zinc (*eta*) between the larger *zeta* flowers have dissolved (see Figure 3). On this basis, the effective metal loss from the coating (in terms of the remaining cross section) is of the order of 5-10% by mass.

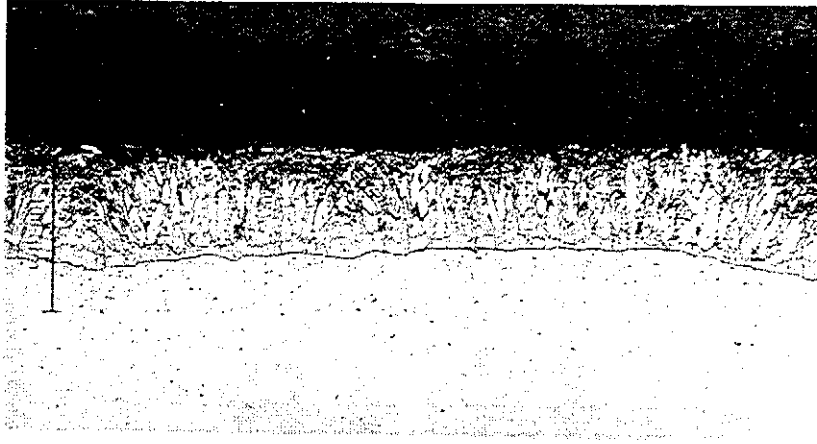
Figure 4. Sample G16 (w/c 0.60, 5% salt solution) after 65 days exposure. (200x)

As further corrosion occurs, the *eta* layer continues to dissolve until it is totally lost from the coating surface. This effect is shown in Figure 4 for sample G16 (w/c 0.6), exposed for 65 days to a 5% salt solution. For this sample, the average thickness of the remaining coating is approximately 70 μ but it is clear that the regions loss of the zinc are intruding deeply into the body of the coating around the *zeta* phase. There is also here evidence of extensive tunnelling through the remaining alloy layers of the coating. As a result, the average coating thickness again does not properly represent the coating thickness loss. When the area of the coating remaining is estimated, it is clear that the amount of metal lost from the surface by this time is of the order of 30%. Note however, that the underlying *delta* alloy layer and much of the *zeta* structure is still largely intact.

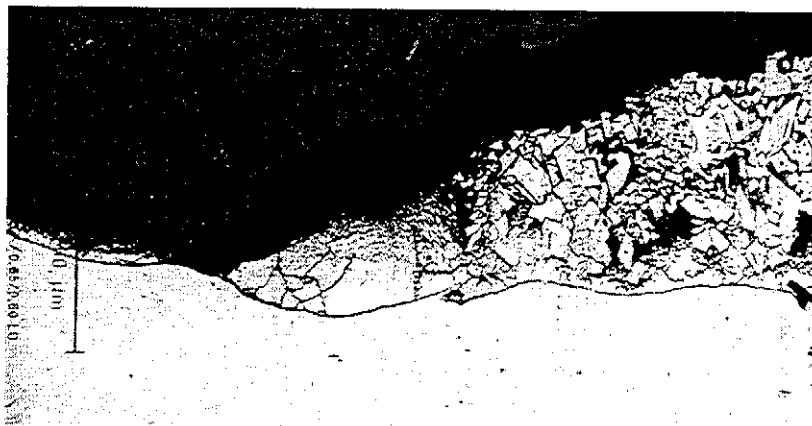
Figure 6. Showing zinc protection of exposed steel sections (200x)

As a final stage to this process, it is interesting to note that where the coating has locally been completely lost and the underlying steel exposed, the steel in close proximity to the remaining zinc is cathodically protected by the sacrificial nature of zinc. An example of this is shown in Figure 6. This can be expected to provide some additional protection to the underlying steel depending on the conductivity of the electrolyte. In accelerated laboratory tests on galvanized rebar in concrete specimens, protection of exposed steel to a distance of about 8 mm has been reported.²

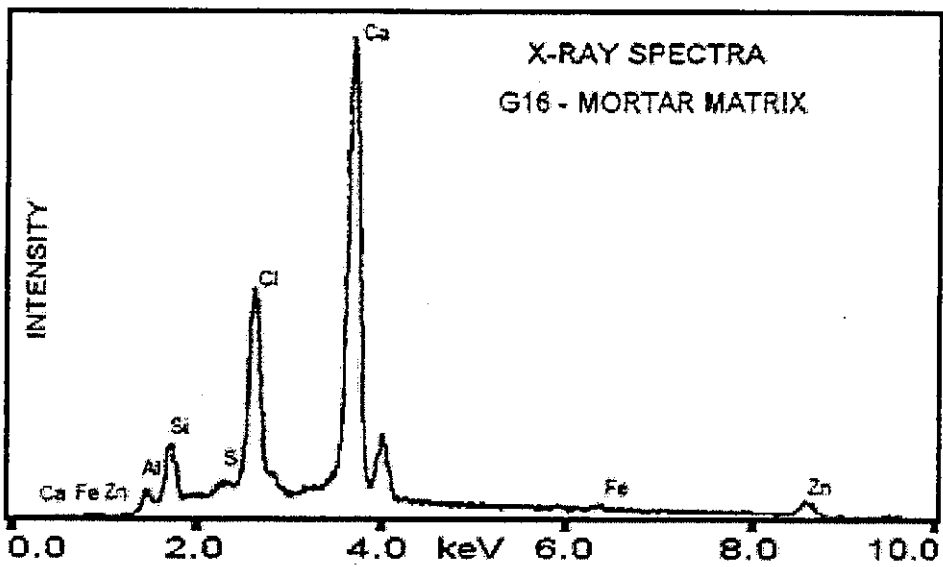
Figure 9. X-ray spectra of mortar matrix for sample G16

X-ray spectra of the mortar matrix and bright phase product are shown in Figures 9 and 10 respectively. The matrix remote from the bar shows strong Ca, Si and Al peaks, and Cl because of the salt water exposure. X-ray powder diffraction of equivalent matrix material revealed the majority presence of Ca(OH)₂ as the mineral Portlandite. The spectra for the bright phase shows similar Ca, Si and Cl peaks but also has strong Zn and Fe peaks. XRD of exuded corrosion product identified the bright phase as the oxide mineral Zincite (ZnO) with no evidence of the presence of complex zinc oxy chloride type minerals. The presence of zinc in the bright phase was also confirmed by a Zn line spectra which clearly

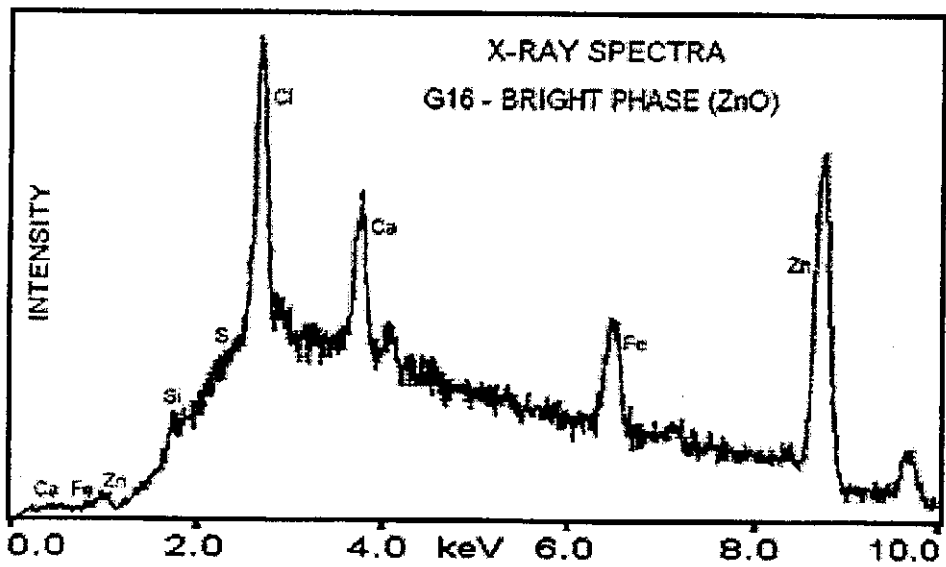
Figure 10. X-ray spectra of bright phase (ZnO) for sample G16
